Image Gallery

Venous anatomy and duplex ultrasound scanning

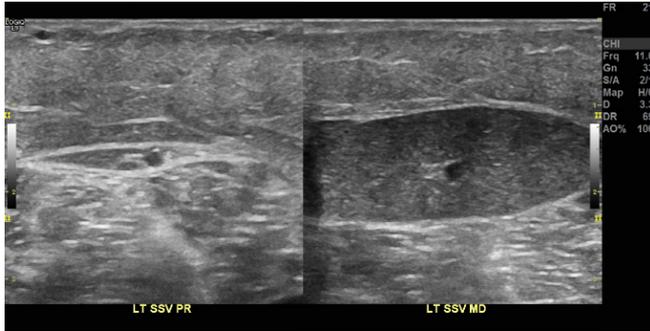
Image 10: Adipose tissue in the saphenous compartment

Transverse view of the SSV at the upper calf (left) and mid-calf (right) level. There is only a small amount of adipose tissue contained within the saphenous compartment. However, the volume of adipose tissue increases towards the lower part of the calf due to gravity and orthostasis. This sonographic appearance is typically observed in women with lipoedema, progressively impairing the lymphatic drainage and leading to saphenous compartment syndrome.

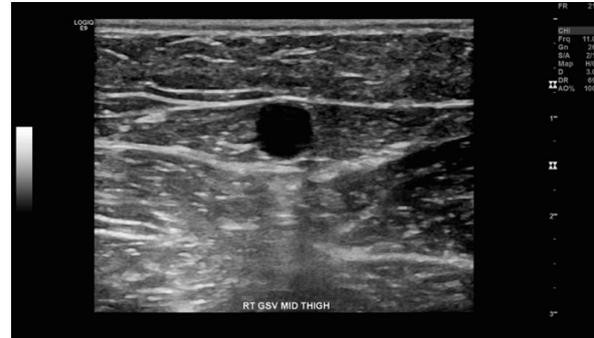
Image 11: Egyptian eye sign

Normal appearance of the GSV at the mid-thigh, showing that the saphenous vein is enclosed by the saphenous fascia and deep muscular fascia. It gives a characteristic sonographic appearance known as 'Egyptian eye' sign.

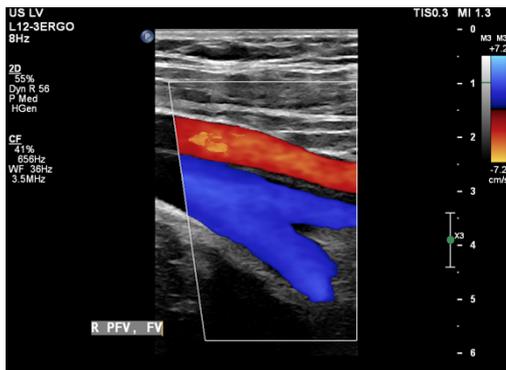
Image 12: Colour image of the CFV

A longitudinal view of the right CFV showing venous flow from the FV and DFV (labelled as PFV in the image) drain into the CFV. (blue: veins; red: artery)

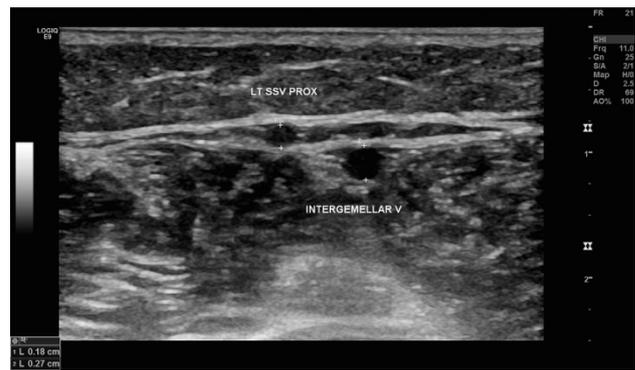
Image 13: Intergemellar vein

Transverse image of the SSV at the upper calf level with an intergemellar vein coursing under the saphenous compartment between the heads of gastrocnemius muscles.

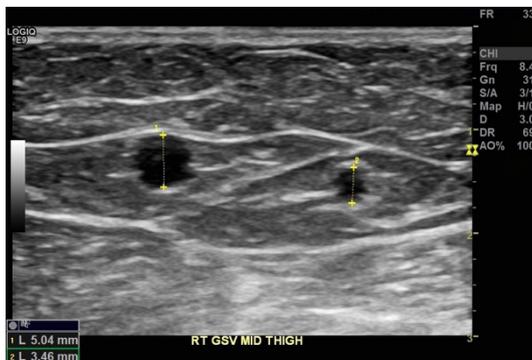
Image 14: Duplication of the GSV

B-mode image shows duplicated GSV at the mid-thigh level with doubled veins within the saphenous compartment.

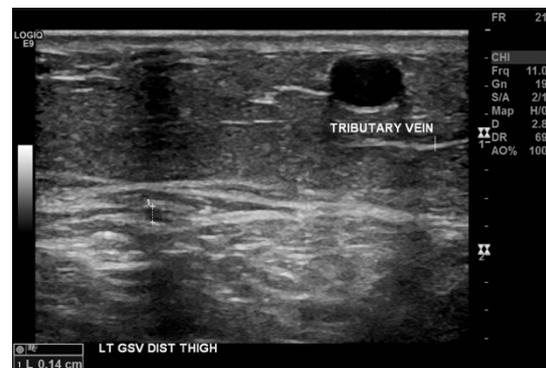
Image 15: Hypoplasia of the GSV

B-mode image shows the hypoplasia of the GSV at the level of the distal thigh with a large epifascial tributary vein that functions as the GSV.

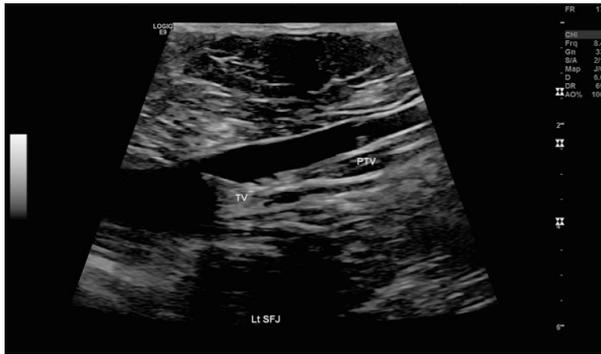
Image 16: The terminal valve (TV) and preterminal valve (PTV)

A longitudinal view of the left SFJ showing TV and PTV in the terminal section of the GSV just below its confluence with the CFV.

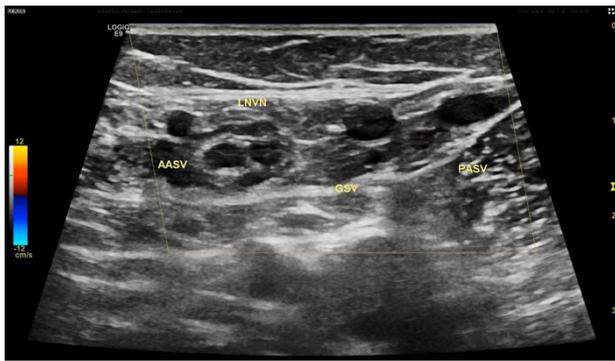
Image 18: PAGSV

B-mode ultrasound image of the PAGSV (labelled as PASV in the image) showing its anatomical relationship with the GSV, LNVN and ASV (labelled as AASV in the image).

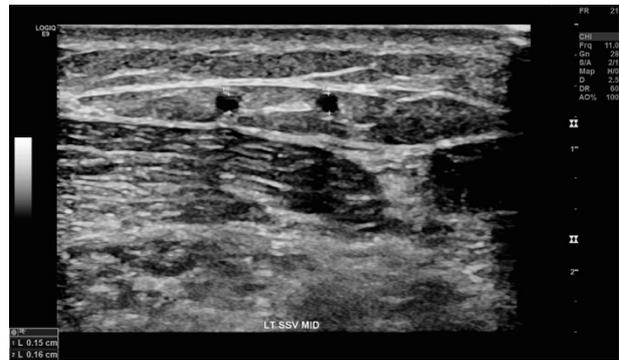
Image 19: Duplication of the SSV

B-mode image shows duplicated SSV at the level of mid-calf with both veins situated within the saphenous compartment.

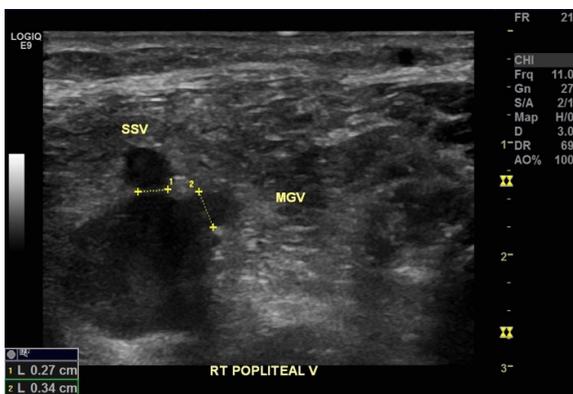
Image 20: Termination of the SSV

B-mode image shows that the SSV and MGV join with the popliteal vein via separate junctions.

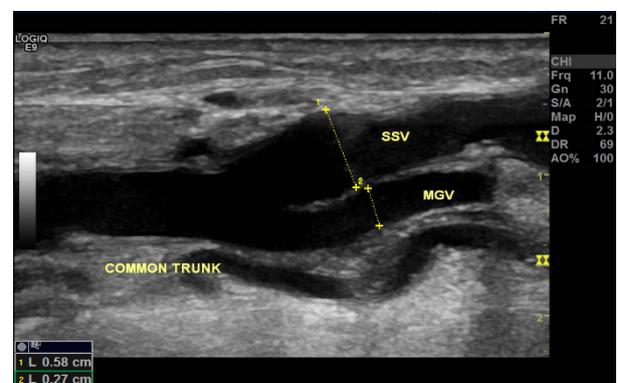
Image 21: Common trunk formed by the SSV and medial gastrocnemius veins (MGV).

Longitudinal B-mode image shows the SSV merges together with the MGV before joining the popliteal vein.

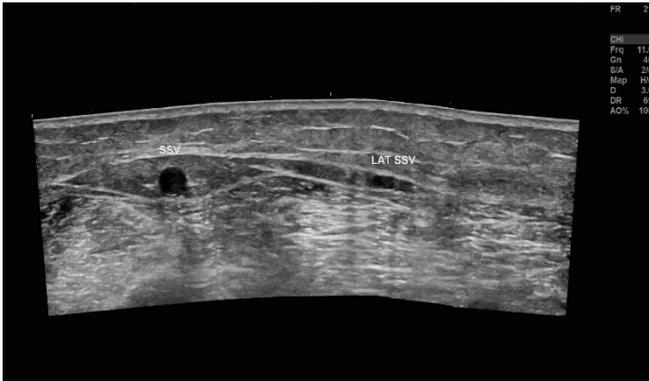
Image 22: Superficial peroneal nerve vein

Panoramic B-mode image of the superficial peroneal nerve vein (labeled as lat SSV in the image) which is situated in its own fascial compartment in the lateral calf.

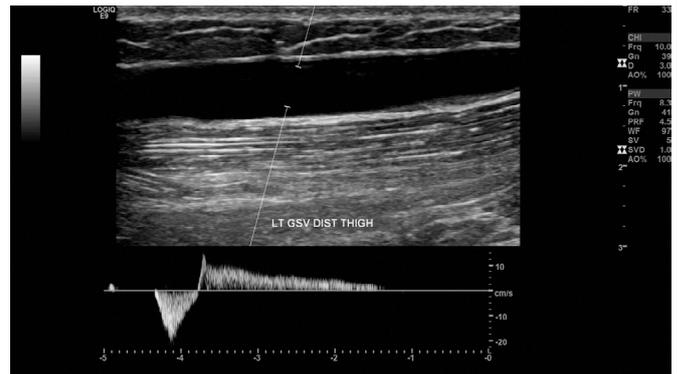
Image 25: Incompetent GSV

Spectral Doppler imaging of the GSV with provocation manoeuvre. The sampled GSV segment demonstrates venous reflux upon the release of augmentation manoeuvre or diastolic phase following muscular contraction.

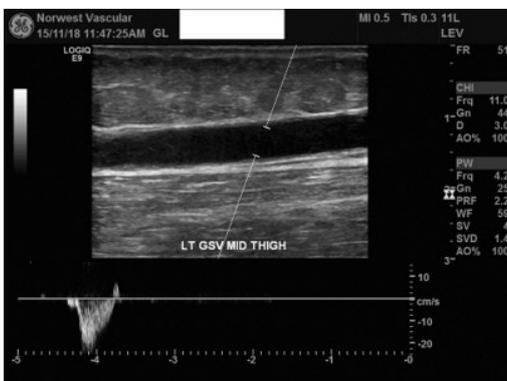
Image 26: Competent GSV

Spectral Doppler imaging of the GSV with provocation manoeuvre. The GSV demonstrates antegrade flow during distal augmentation manoeuvre and a brisk of physiological reversed flow on relaxation, indicating valvular competence in the sampled GSV segment.

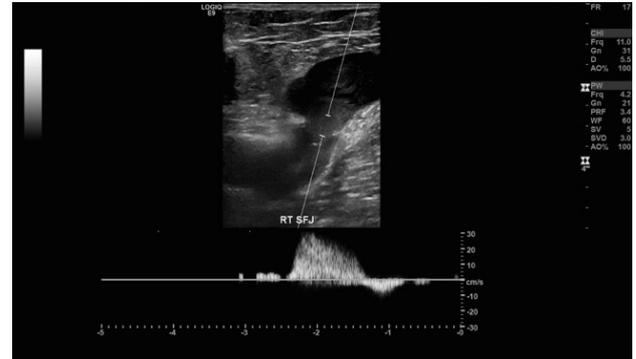
Image 29: Systolic reflux at the SFJ

In the presence of obstructive disease in the ipsilateral iliofemoral veins, reversed flow (systolic reflux) is demonstrated at the right SFJ during provocation manoeuvre, that is further drained via collateral veins. Brisk antegrade flow upon relaxation suggests competent terminal valves.

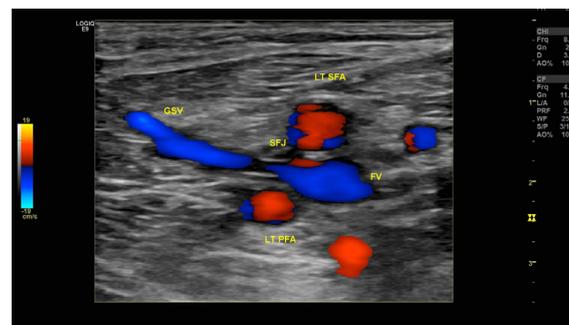
Image 32: Anatomical variant of the SFJ with the GSV passing through the gap between the SFA and PFA

Colour Doppler image of the left SFJ shows the terminal section of the GSV is sandwiched by the SFA and PFA (Profunda Femoris Artery).

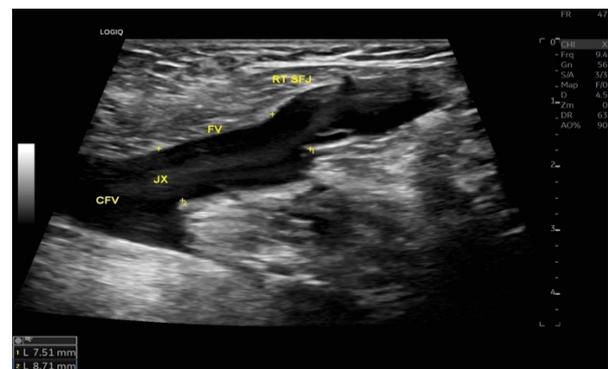
Image 33: Variable termination of the GSV (SFJ: GSV-FV)

Longitudinal B-mode image of the right SFJ shows the GSV terminates into the FV instead of the CFV. (JX: termination of the FV into the CFV)

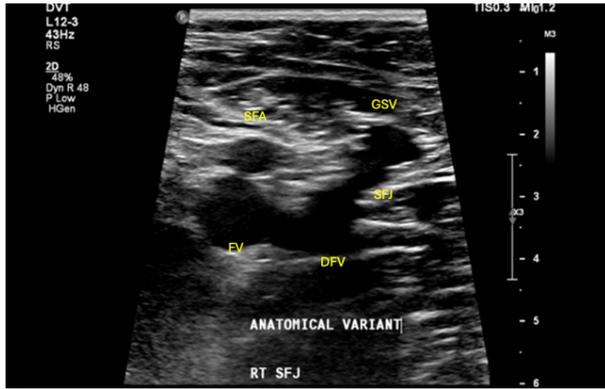
Image 34: Variable termination of the GSV (SFJ: GSV-DFV)

Transverse B-mode image of the right SFJ shows the GSV terminates into the DFV instead of the CFV.

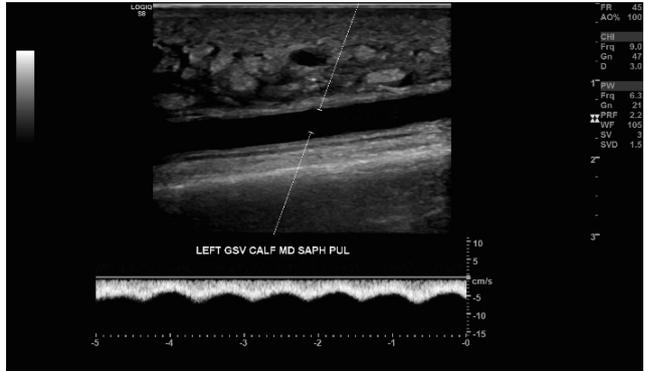
Image 35: Saphenous pulsation

At rest, the left GSV calf segment exhibits antegrade flow with a pulsatile pattern, indicative of saphenous pulsation. Notably, the spectral tracing shows no retrograde flow component, and the phenomenon is typically observed in patients with advanced stages of CVD/CVI, likely as a result of microcirculatory failure.

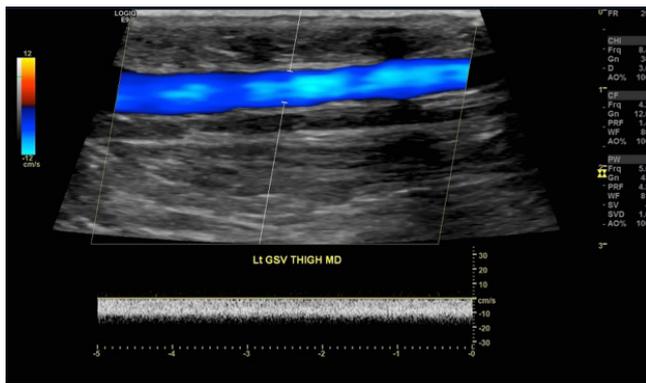
Image 36: Continuous flow in the GSV

At rest, the GSV demonstrates continuous antegrade flow due to venous obstruction in the femoropopliteal veins. Flow volume and velocity may increase when the patient lies in the supine position due to a reduction in the hydrostatic pressure gradient.

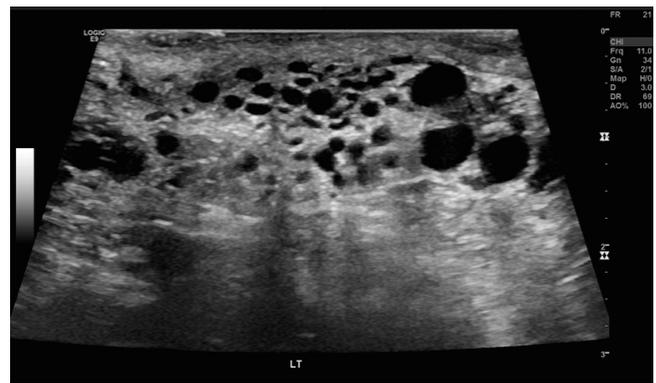
Image 37: Varicocele

Ultrasound image of varicocele shows dilated, tortuous veins within the scrotum, with increased echogenicity and noncompressibility, characteristic of a varicocele. The veins exhibit a "bag of worms" appearance, indicative of impaired venous drainage.

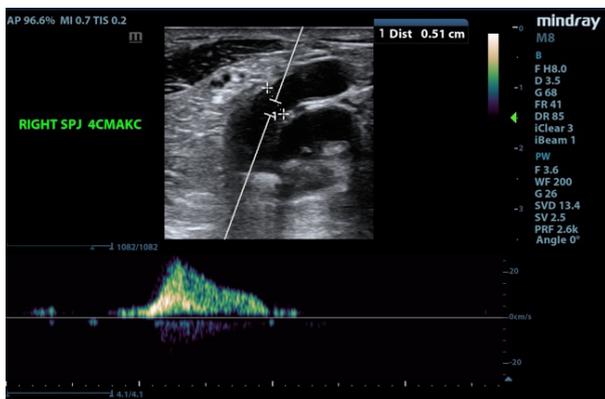
Image 38: Systolic reflux at the SPJ

During a provocation manoeuvre, augmented flow is observed traveling from the popliteal vein back to the SSV via the SPJ, indicating systolic reflux. However, upon relaxation, diastolic flow is absent on the spectral Doppler tracing, suggesting venous obstruction in the femoropopliteal vein and a competent SPJ.

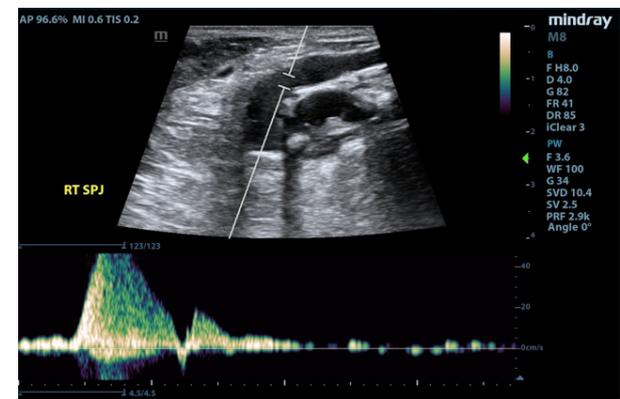
Image 39: Systolic and diastolic reflux at the SPJ

During a provocation manoeuvre, augmented flow travels from the popliteal vein back into the SSV via the SPJ. Diastolic flow is also reversed and prolonged, indicating SPJ incompetence. The co-occurrence of systolic and diastolic reflux is due to venous obstruction in the femoropopliteal vein.

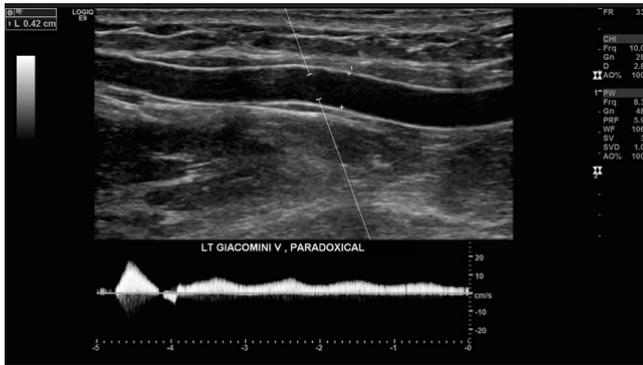
Image 40: Paradoxical reflux in the vein of Giacomini

The Giacomini's vein demonstrates flow in antegrade direction during both muscular systole and diastole. The diastolic flow most likely represents flow exiting out of the SPJ from the popliteal vein. This ascending reflux is known as paradoxical reflux.

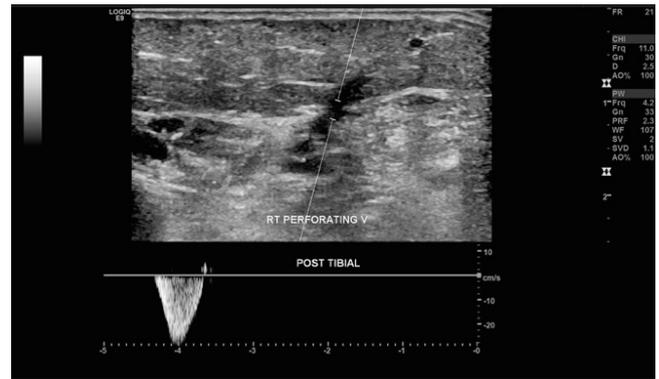
Image 41: Competent perforating vein

An ultrasound image of a competent posterior tibial perforating vein shows inward flow during augmentation and brisk reversed flow upon relaxation (systolic: inward; diastolic: outward).

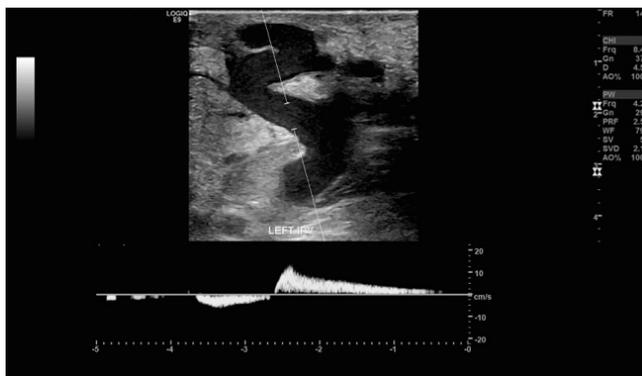
Image 42: Incompetent calf perforating vein

The posterior tibial perforating vein shows inward flow during augmentation and reversed flow of long duration upon relaxation, indicating perforating vein incompetence.

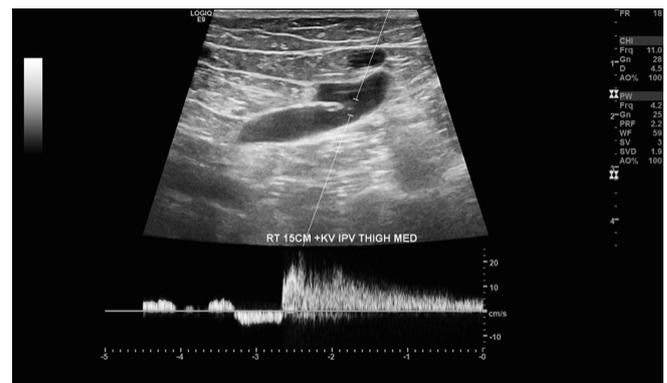
Image 43: Incompetent thigh perforating vein

This thigh perforating vein is identified as the source of reflux responsible for recurrent thigh varicosities. During a provocation maneuver, the flow direction is inward, but upon relaxation, prolonged reversed flow is observed on the spectral tracing, indicating perforating vein incompetence.

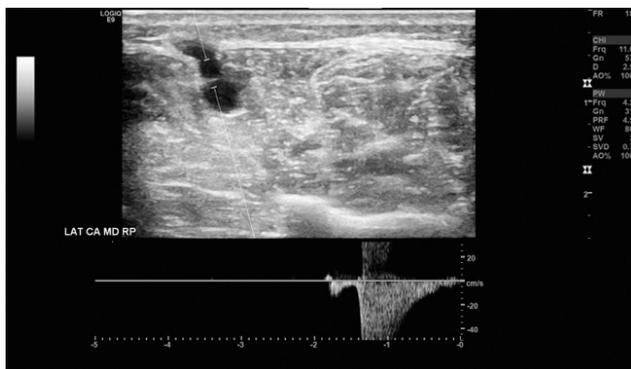
Image 44: Re-entry perforating vein with systolic and diastolic inflow

The lateral calf perforating vein demonstrates inward flow during and after augmentation (systolic: inward; diastolic: inward). This perforating vein functions as a re-entry point, draining superficial venous reflux.

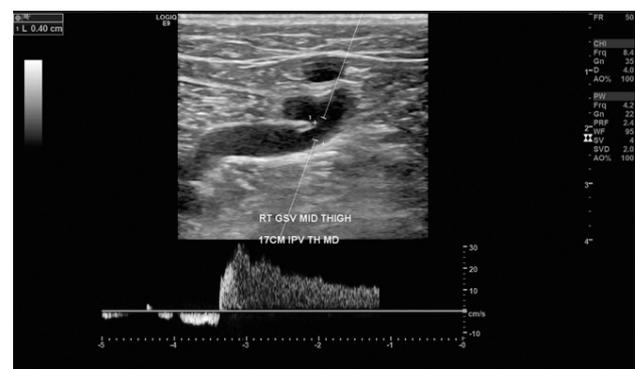
Image 45: Incompetent perforating vein or with systolic inflow and diastolic outflow

The mid-thigh perforating vein demonstrates inward flow during augmentation and outward flow upon relaxation (systolic: inward; diastolic: outward). This thigh perforating vein is identified as the source of reflux or an escape point.

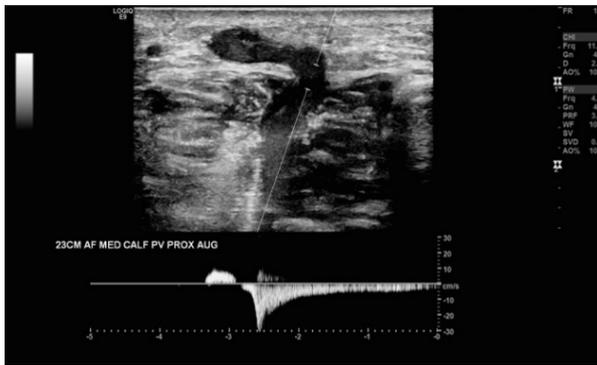
Image 46: Re-entry perforating vein with systolic outflow and diastolic inflow

The medial calf perforating vein shows outward flow during augmentation and inward flow upon relaxation (systolic: outward; diastolic: inward). This perforating vein functions as a re-entry point; however, systolic flow suggests the possibility of deep vein obstruction or incompetence.

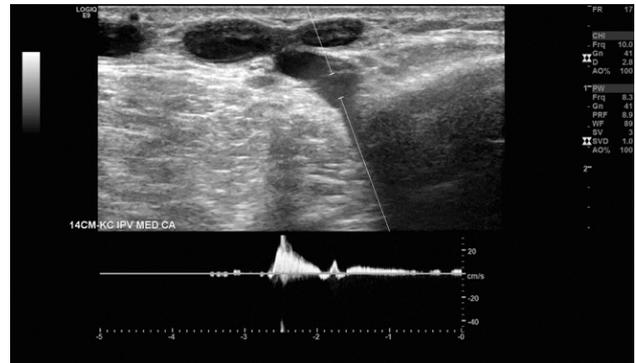
Image 47: Incompetent perforating vein or with systolic and diastolic outflow

The paratibial perforating vein shows outward flow during and after augmentation manoeuvre (systolic: outward; diastolic: outward). This perforating vein is defined as the source of reflux or escape point. Additionally, its systolic flow suggests the possibility of deep vein obstruction or incompetence.

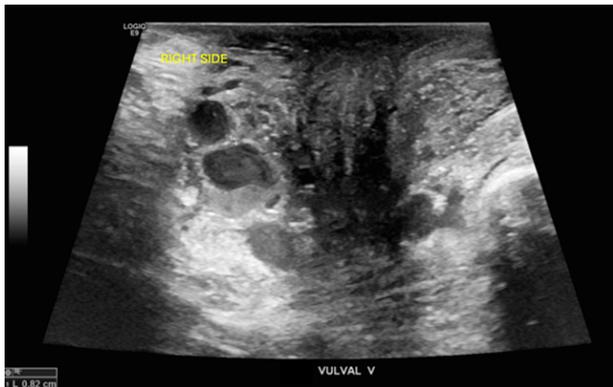
Image 48: Vulval varicosities

B-mode image of a patient with right sided vulval varicosities.

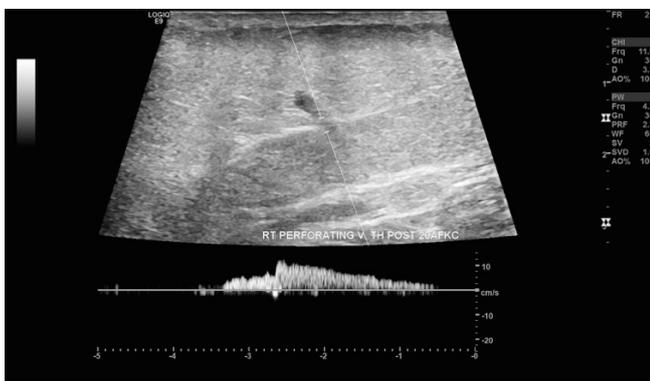
Image 50: Gluteal perforating vein

Spectral Doppler analysis of the gluteal perforating vein shows minimal inward flow during augmentation and reversed flow of prolonged duration on the release of augmentation manoeuvre, indicating perforating vein incompetence.

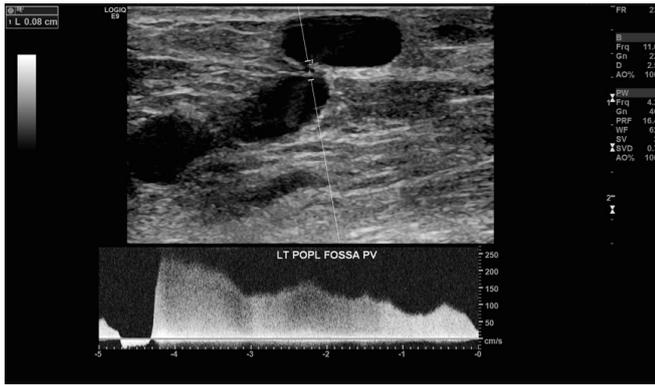
Image 52: Popliteal fossa perforating vein

Spectral Doppler imaging of the popliteal fossa perforating vein shows inward flow during muscular contraction followed by high velocity, high volumed reflux flow upon relaxation.

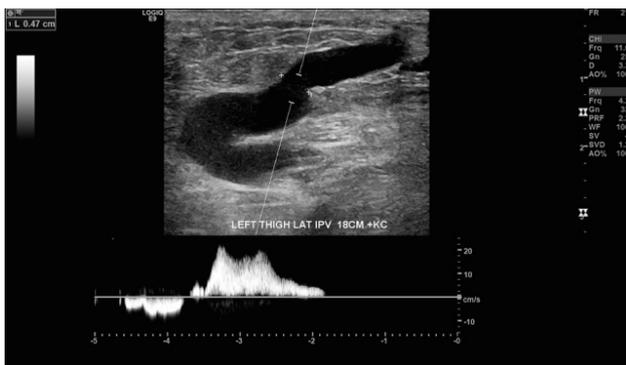
Image 54: Posterolateral thigh perforating vein

Spectral Doppler imaging of the left posterolateral thigh perforating vein shows inward flow (superficial to deep) during augmentation and outward flow (deep to superficial) of prolonged duration, indicating perforating vein incompetence.

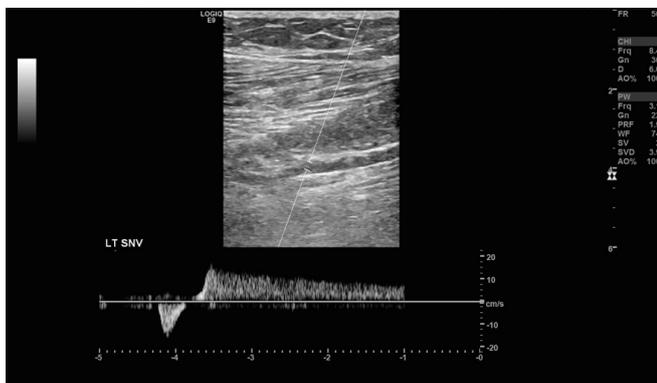
Image 56: SNV

Spectral Doppler imaging of sciatic nerve varices shows antegrade flow during augmentation and reversed flow of prolonged duration on relaxation.

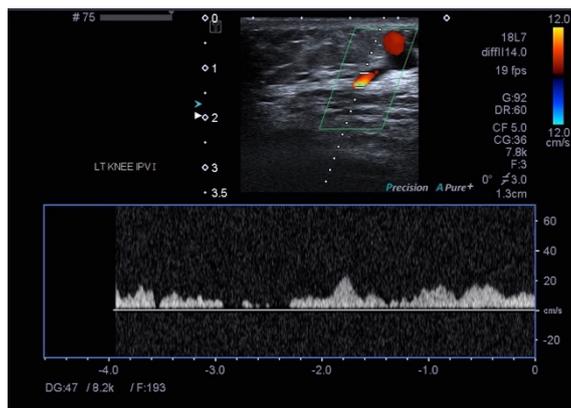
Image 58: Incompetent knee perforating vein

Spectral Doppler imaging of the knee perforating vein shows reflux flow during muscular contraction and relaxation, indicating perforating vein incompetence.

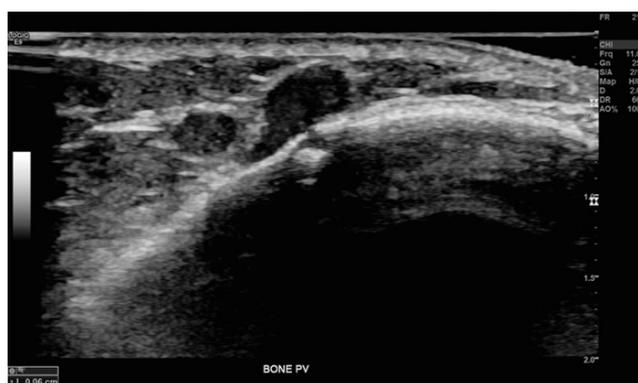
Image 60: Bone perforating vein

B-mode image of a bone perforating vein shows a small osteolytic defect on the tibial shaft with diameter 0.6mm.

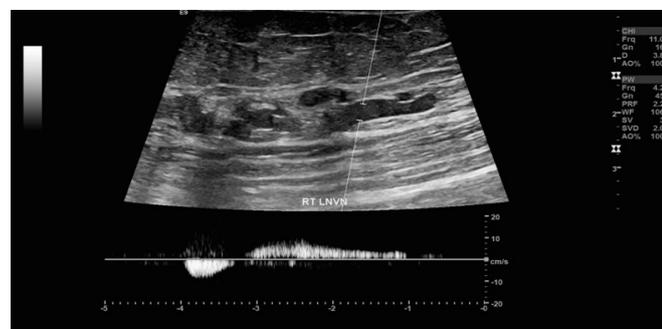
Image 62: Incompetent LNVN

Spectral Doppler imaging of the LNVN shows augmented flow in antegrade direction and reflux flow on relaxation.

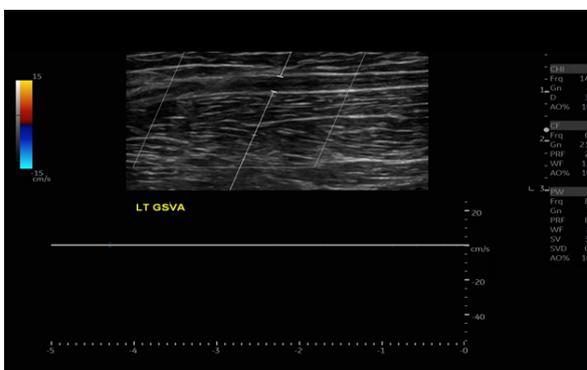
Image 63: Ablated GSV following EVLA

Spectral and colour Doppler imaging shows absence of flow signals in the GSV thigh segment that has undergone EVLA treatment.

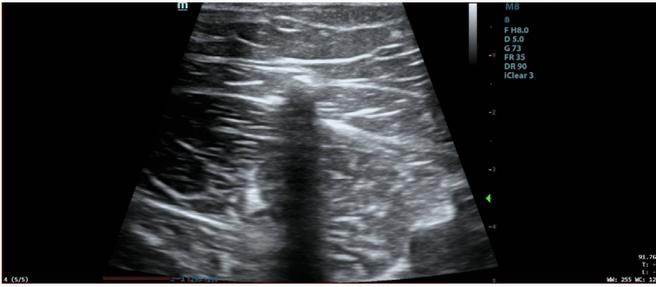
Image 64: The GSV following cyanoacrylate glue ablation
B-mode image of the GSV shows acoustic shadowing caused by the cyanoacrylate glue.

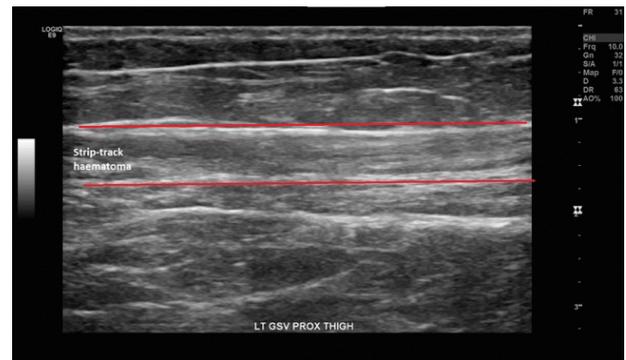
Image 65: Strip-track haematoma postGSV stripping surgery

Postoperative image of the saphenous compartment showing strip-track haematoma following GSV stripping surgery.

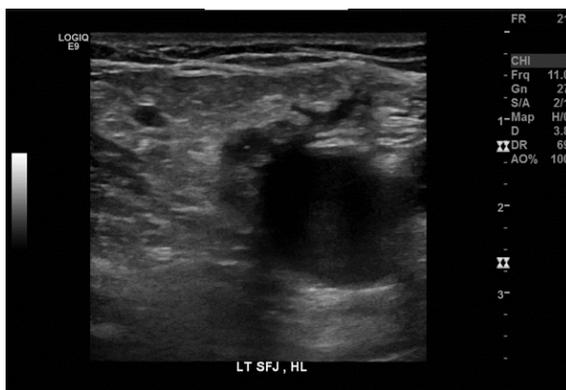
Image 66: SFJ post high ligation

Postoperative image of the former SFJ following flush ligation.

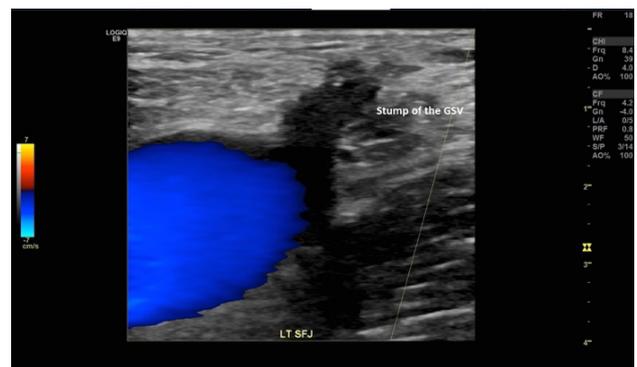
Image 67: SFJ with a GSV stump post ligation

Postoperative image of the left SFJ following low ligation with a residual GSV stump.

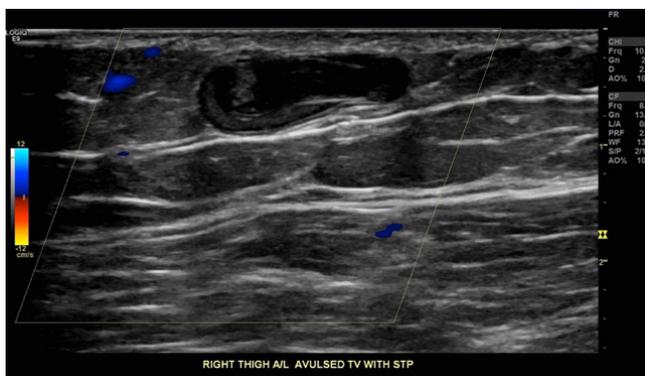
Image 68: STP postavulsion

Ultrasound image of an avulsed thigh tributary vein with superficial venous thrombosis and absence of vascularity.

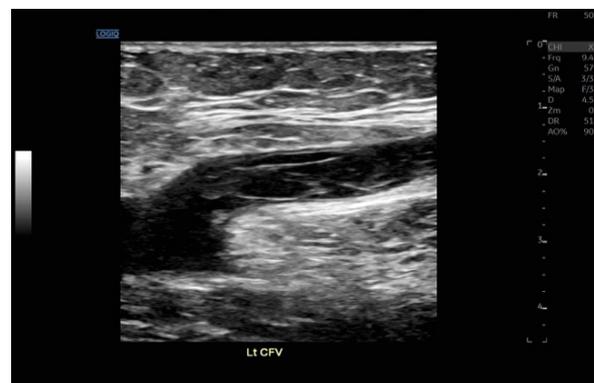
Image 69: Type I EHIT

Type I EHIT where the thrombosis stops at the SFJ.

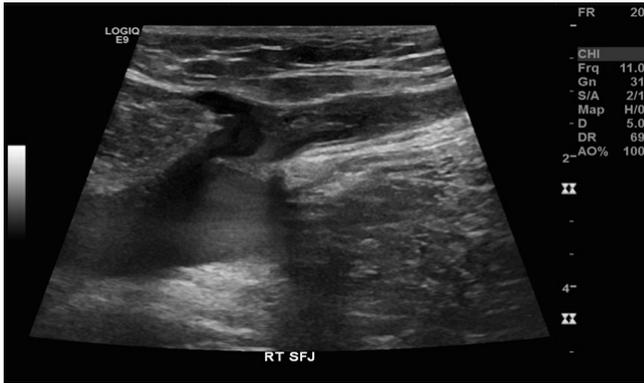
Image 70: Type II EHIT

Type II EHIT where the thrombus extends into the CFV causing less than 50% of luminal reduction.

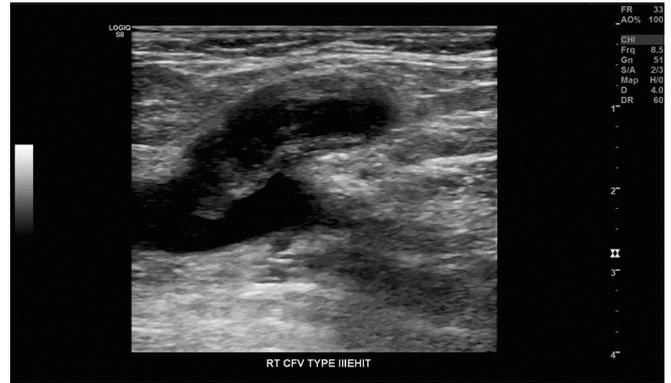
Image 71: Type III EHIT

Type III EHIT where the thrombus extends into the CFV causing greater than 50% of luminal reduction.

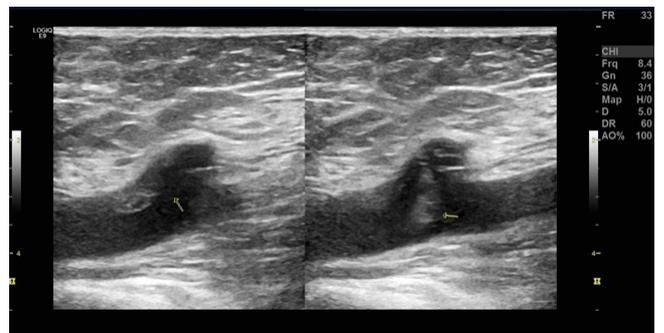
Image 73: Mobile EHIT

B-mode image displaying a mobile type of the EHIT reveals a flap at the SFJ following the EVLA procedure.

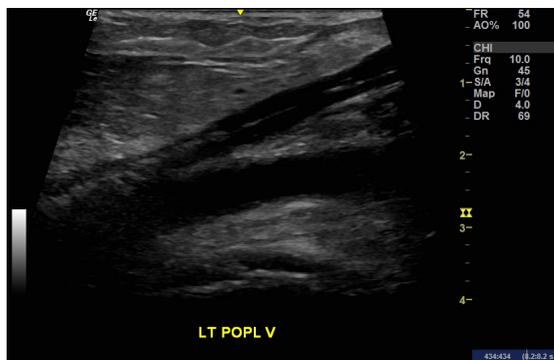
Image 74: EGIT

Extension of the glue into the left popliteal vein following cyanoacrylate glue ablation of the SSV.

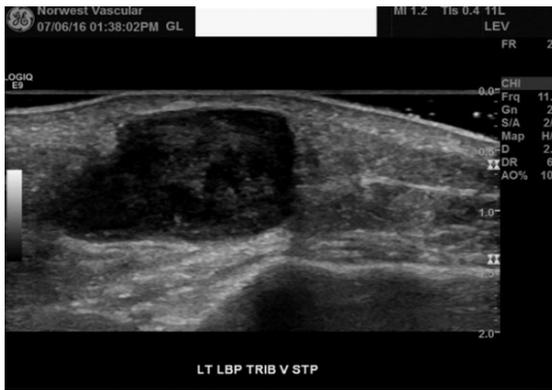
Image 76: STP

An acute superficial thrombus spontaneously formed in the large varicose tributary vein, showing mixed echogenicity.

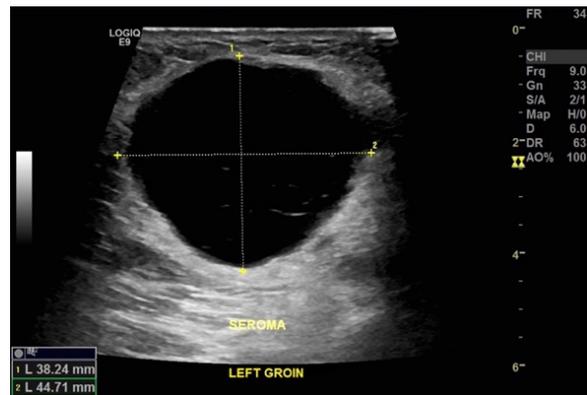
Image 77: Seroma

Ultrasound image of an inguinal seroma that is formed after the SFJ ligation and stripping of the GSV.

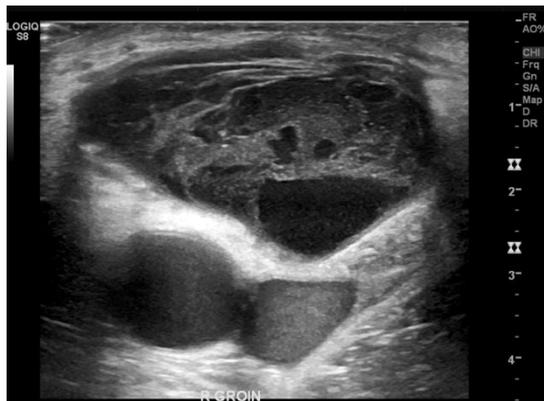
Image 78: Haematoma

Ultrasound image showing a large, well defined, oval-shaped haematoma formed after the SFJ ligation. It has mixed echogenic content, whorled appearance in the anterior region and a fluid component along the posterior wall.

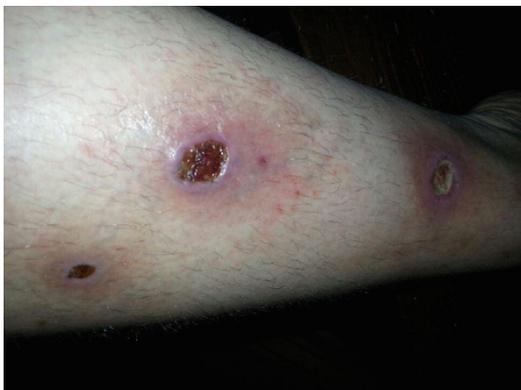
Image 80: Cutaneous necrosis

Cutaneous necrosis after injection with polidocanol 1% into telangiectasia. Superficial ulceration is present on the anterior aspect of the calf at week 2.

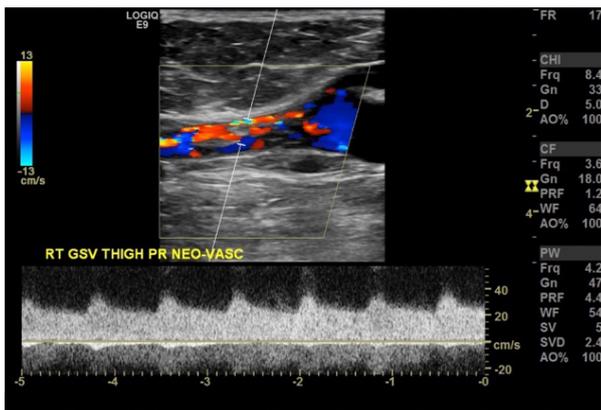
Image 82: Neovascularisation post ELVA

Spectral and colour Doppler image shows neovascularisation within a previously ablated GSV with arterialised venous flow in retrograde direction flushing the treated segment.

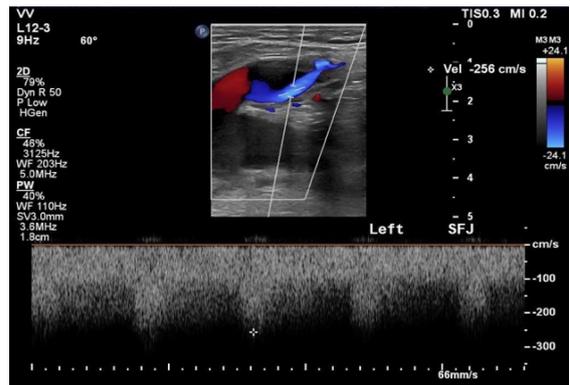
Image 83: Iatrogenic AVF

The left SFJ exhibits arteriased venous flow of high velocity and high volume due to arteriovenous fistula caused by needle injury during the administration of tumescence anaesthesia.

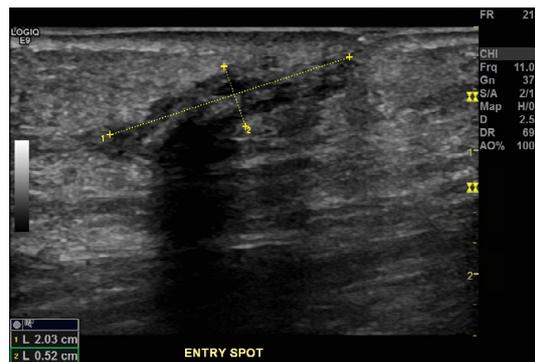
Image 85: Granuloma

B-mode image of a granuloma at the venous access site following cyanoacrylate glue ablation shows an irregularly shaped lesion with heterogeneous echogenicity and acoustic shadowing cast by the glue.

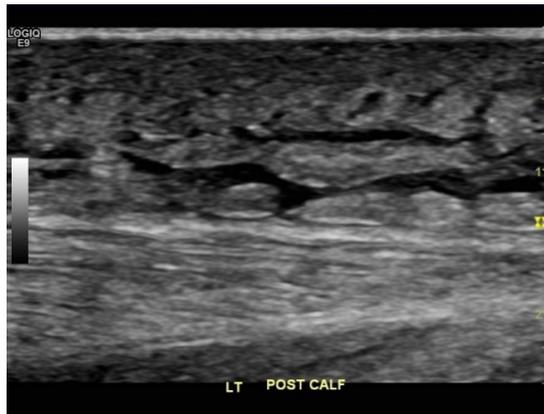
Image 88a: Venous oedema

Ultrasound image of the left posterior calf showing hypochoic area within the subcutaneous tissue, in keeping with fluid accumulation as a result of venous hypertension secondary to CVI.

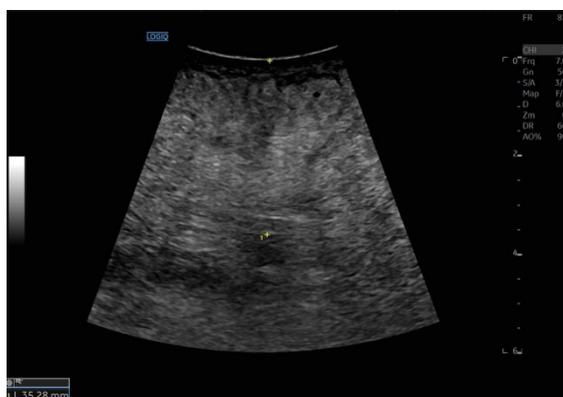
Image 91: Lipoedema

Ultrasound image of the patient's leg with lipoedema shows thickened subcutaneous fat.

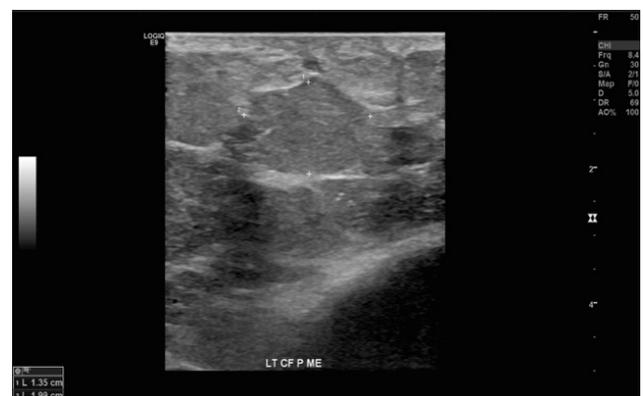
Image 92: Lipoma

Ultrasound image of a lipoma shows a well-defined, hyperechoic mass within the subcutaneous tissue, with homogenous texture and smooth margins, consistent with the benign characteristics of a lipoma.

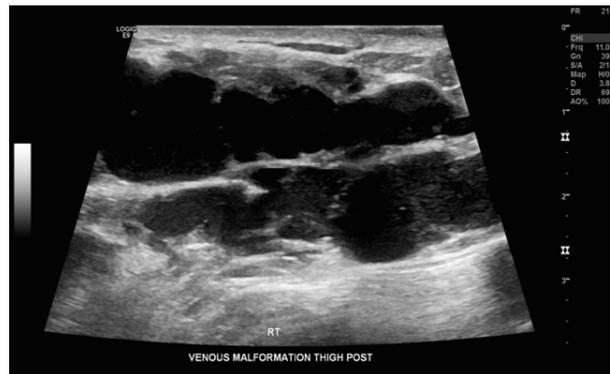
Image 94: Venous malformation

B-mode ultrasound image of an intramuscular venous malformation at the posterior thigh shows tubular, sponge like spaces within the muscle, with no evidence of thrombi.

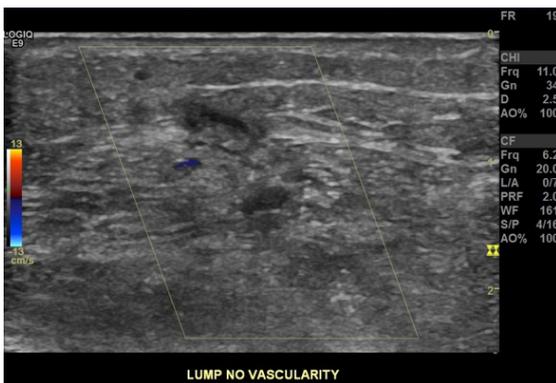
Image 95: Muscle hernia

Ultrasound image of a muscle hernia shows a focal defect in the fascia, through which a portion of the underlying muscle protrudes. The herniated muscle appears as a hypoechoic mass extending through the fascial defect, especially prominent during muscle contraction.

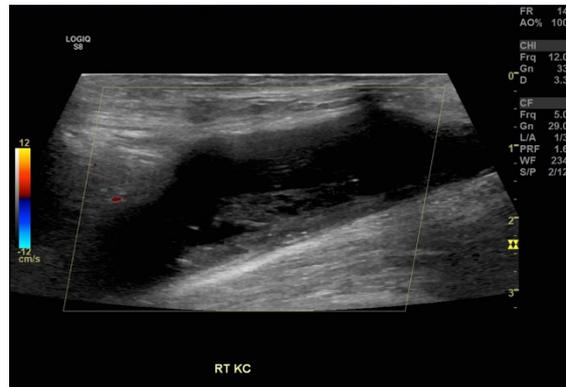
Image 96: Baker's cyst

Ultrasound image of a baker's cyst with internal echogenic material suggestive of an old haemorrhage.

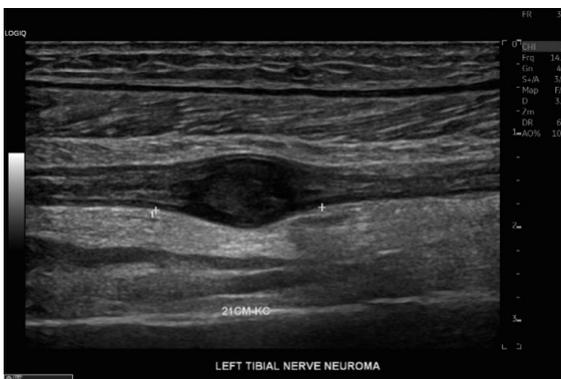
Image 97: Neuroma

Ultrasound image of the tibial nerve neuroma shows a bulbous, hypoechoic, well circumscribed mass in the tibial nerve.

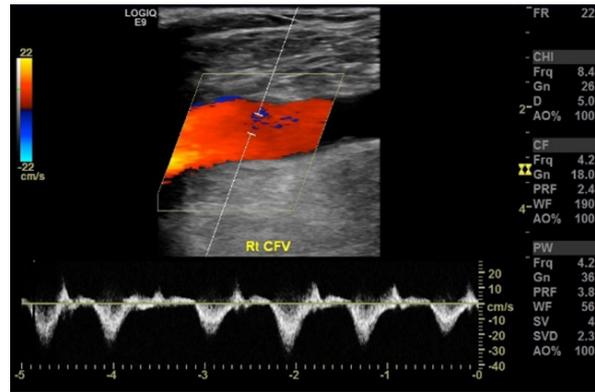
Image 100: Transmitted pulsatility in the CFV

Spectral Doppler imaging of the right CFV shows spontaneous flow with pulsatile retrograde flow, suggesting a possible right sided heart problem such as tricuspid regurgitation.
