SONOGRAPHY OF THE GRAVID CERVIX: IMAGE GALLERY

This image gallery is supplementary to the evidence based clinical guideline for sonographers: *Ultrasound assessment of the gravid cervix to assess for risk of preterm birth*. It is designed to aid sonographers in capturing and interpreting sonographic images and making measurements from those images when assessing the gravid cervix.

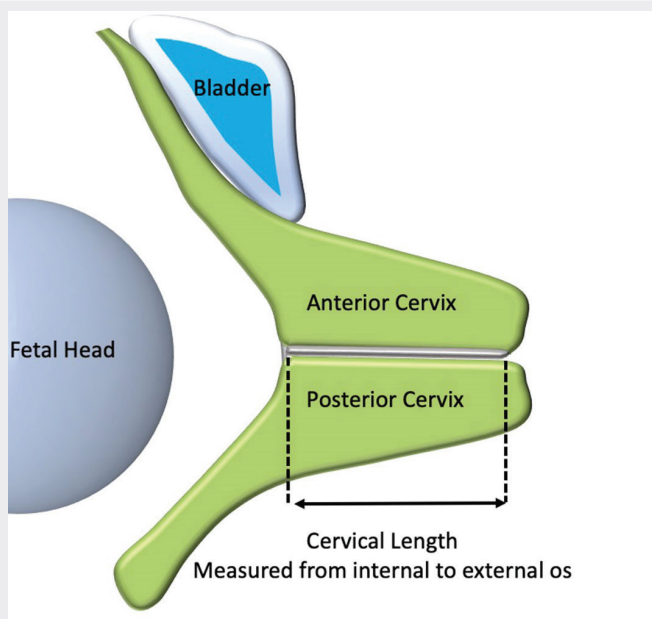
Image 1: Schematic representation of cervical length measurement of gravid cervix (adapted from Ultrasound evaluation of the gravid cervix. Obgyn Key; Available from: <https://obgynkey.com/ultrasound-evaluation-of-the-gravid-cervix/>)

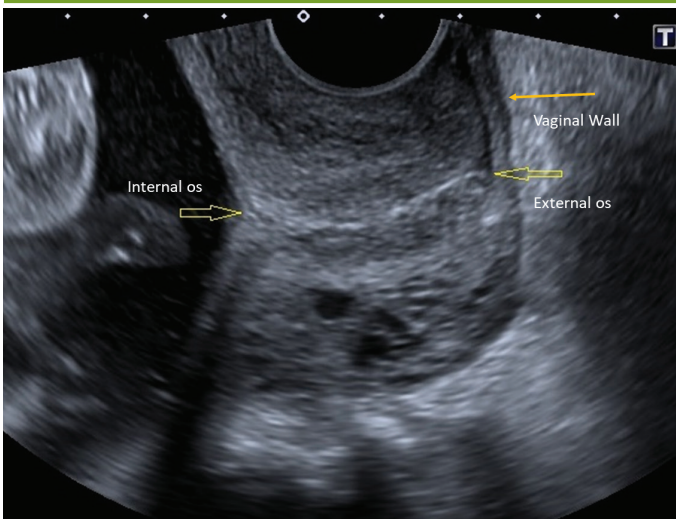
Image 3: Key anatomy of normal cervix.

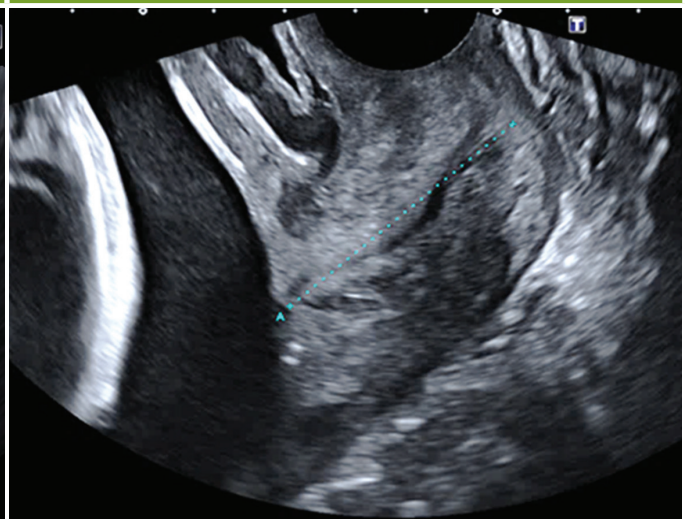
Image 4: Cervix of normal length (with measurement).

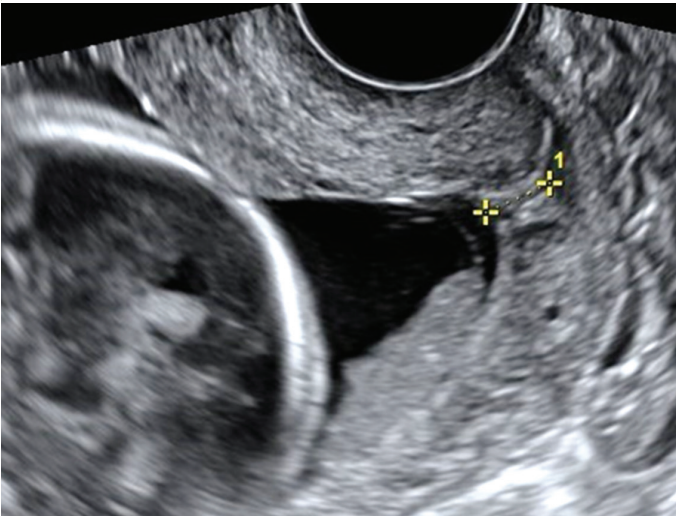
Image 5: Image of short cervix (with measurement, demonstrating amniotic sludge on the posterior wall of the opened cervix).

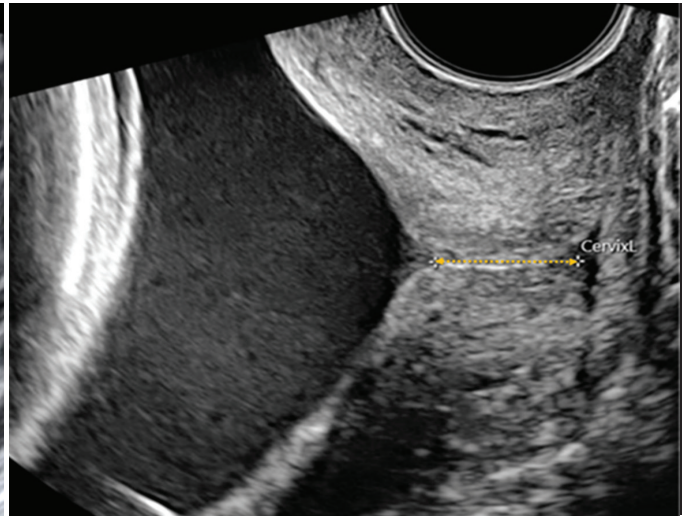
Image 6: Image of short cervix (with measurement).

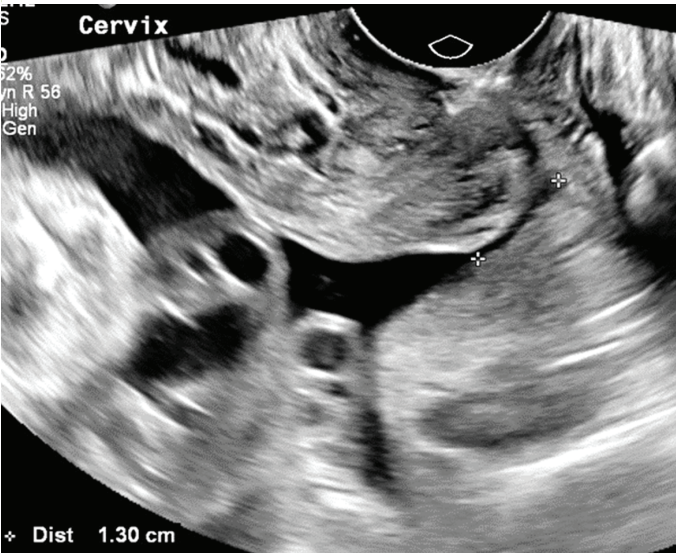
Image 7: Image of short cervix (with measurement and demonstrating Y shaped funnelling).

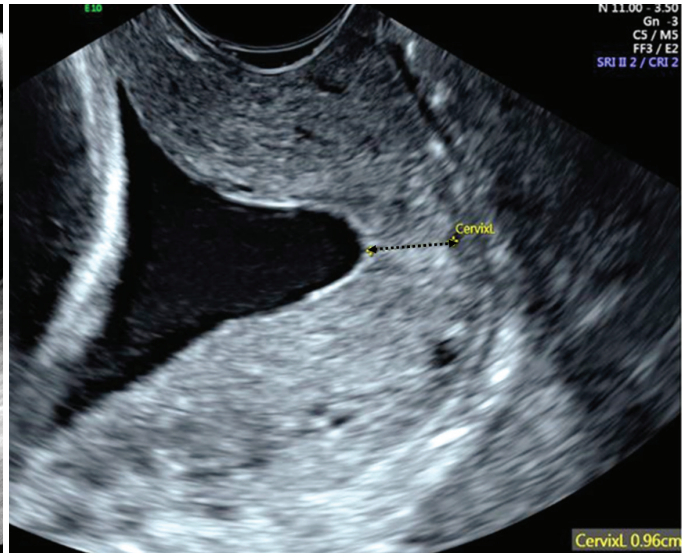
Image 8: Image of short cervix (with measurement and demonstrating U-shaped funnelling).

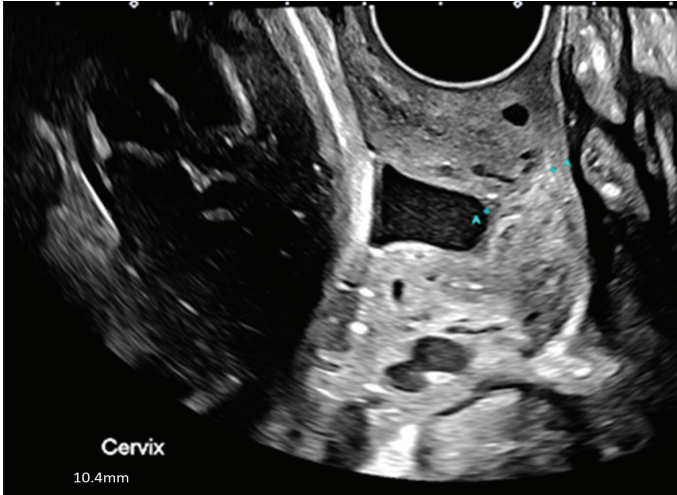
Image 9: Image of short cervix (demonstrating U-shaped funnelling)

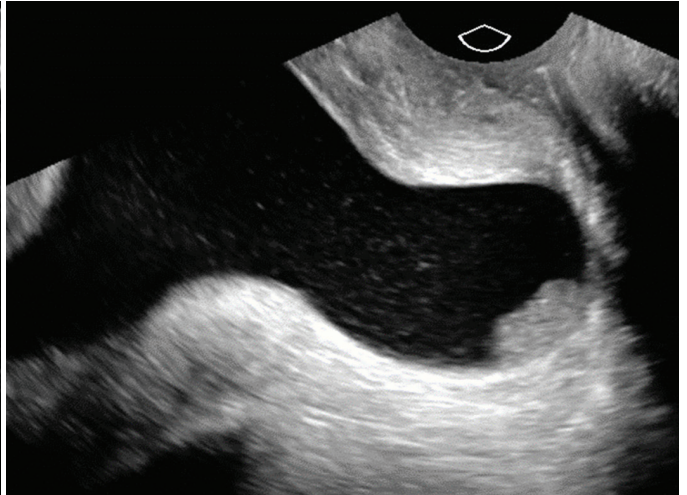
Image 10: Example of dilated cervix with funnelling (u-shaped, with sludge and no measurable cervix).

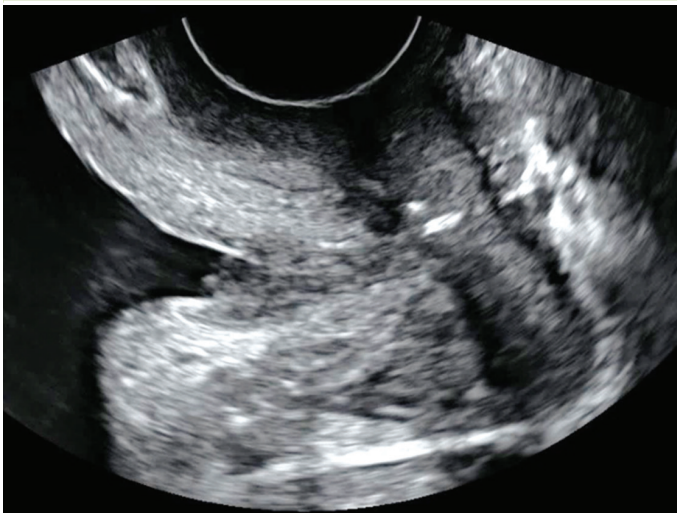
Image 11: Example of funnelling (v-shaped).

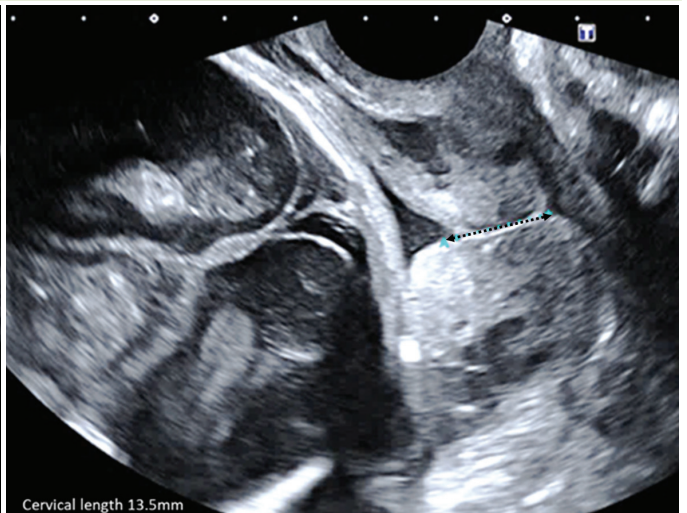
Image 12: Example of funnelling (v-shaped).

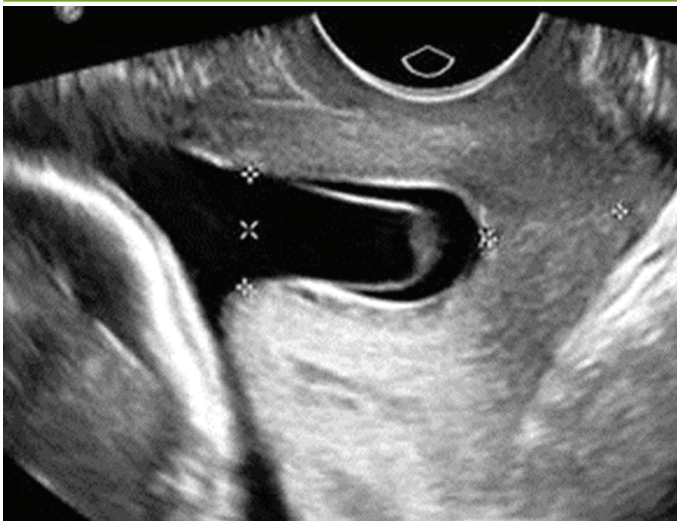
Image 13: Example of amnio-chorionic separation prolapsing into the open cervical canal.

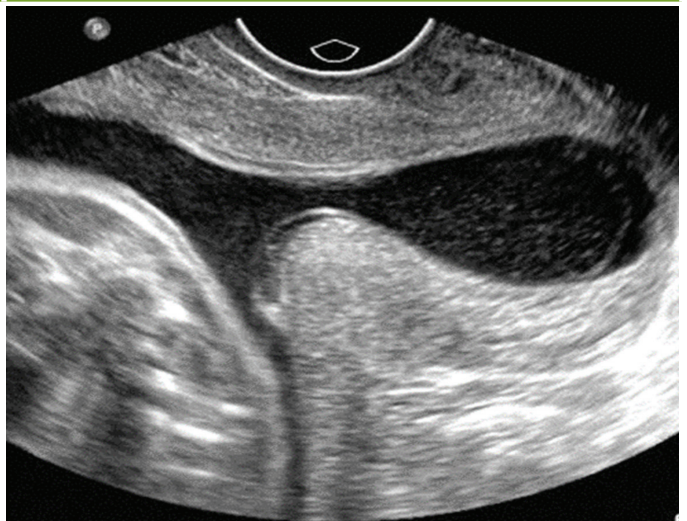
Image 14: Example of endocervical canal dilation with prolapsing membranes and no measurable cervix.

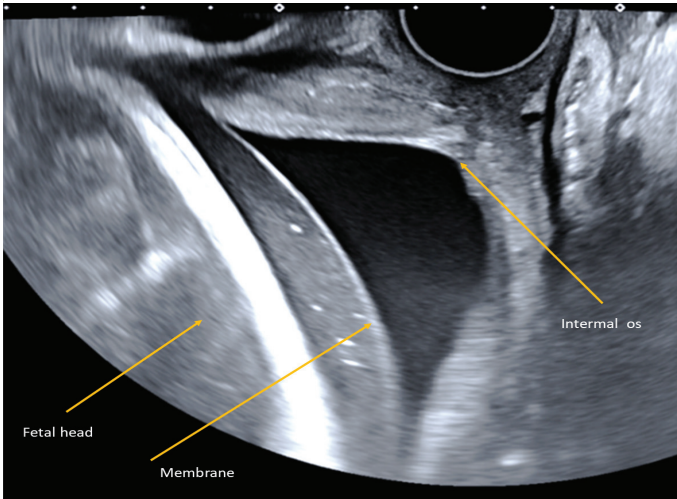
Image 15: Short cervix and membranes bridging the funnelling part of the cervix.

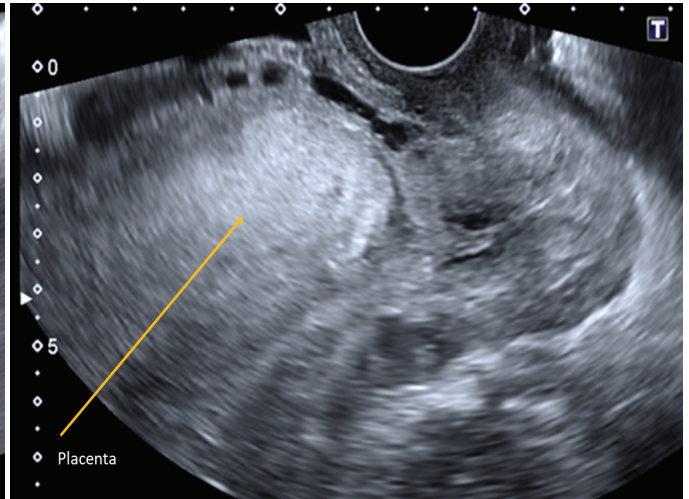
Image 16: Long closed cervix and placenta praevia.

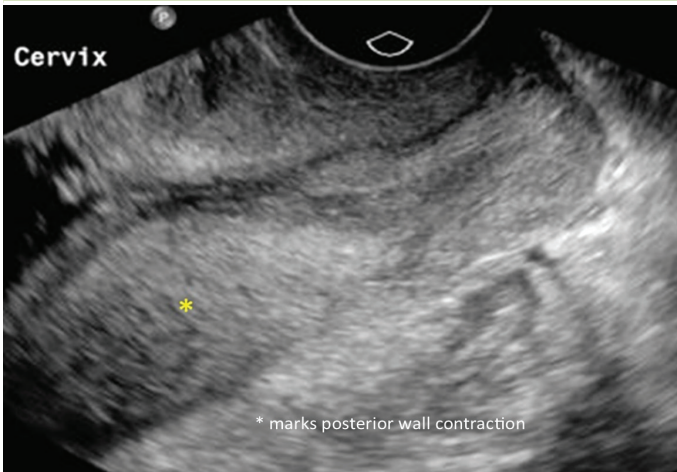
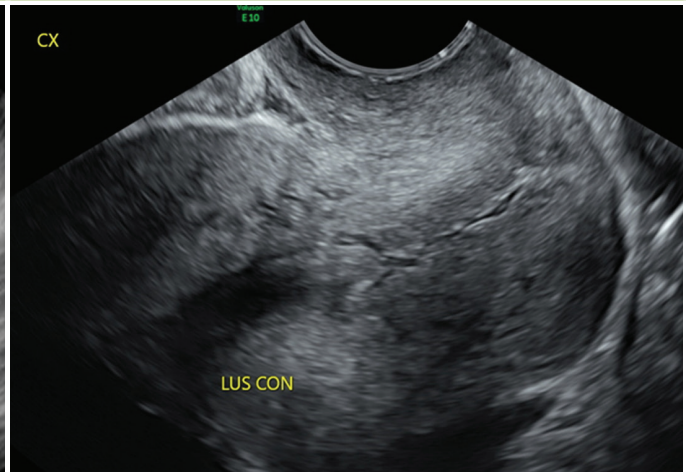
Image 17: Examples of lower uterine contractions.

Note: to confirm a uterine wall contraction it should be visualised over time to see it change.

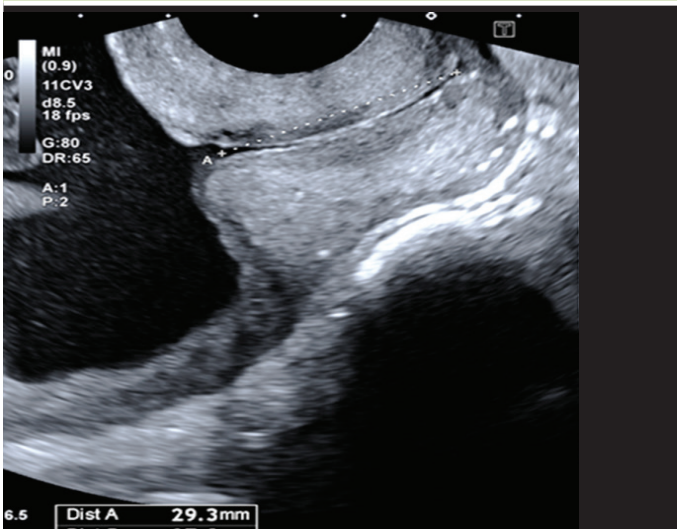
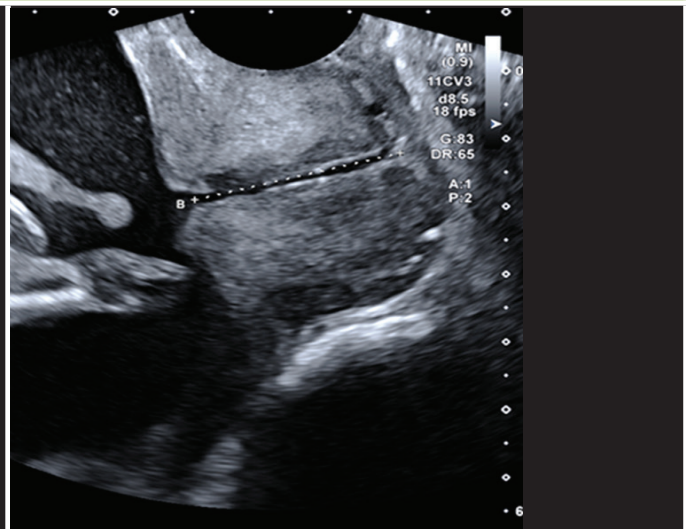
Image 18: Comparison images. Left: elongation of the cervical length by too much transducer pressure compressing the anterior portion of the cervix. Right: Correct transducer pressure, the anterior and posterior portions of the cervix being similar widths.

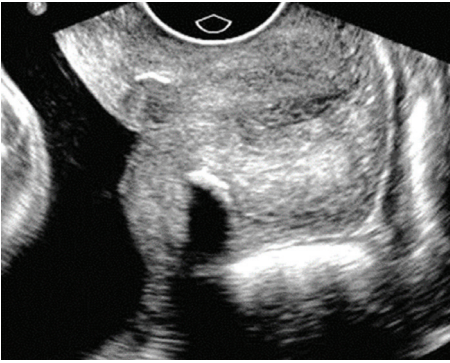
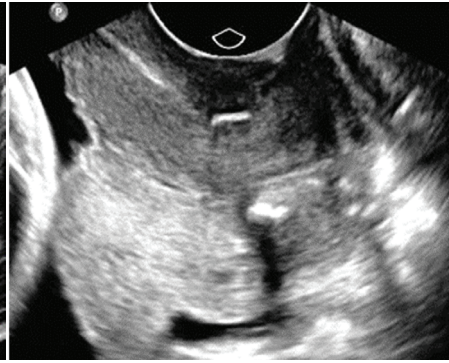
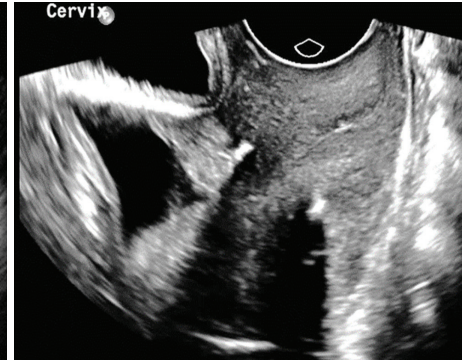
Image 19a: Examples of cerclage in-situ.

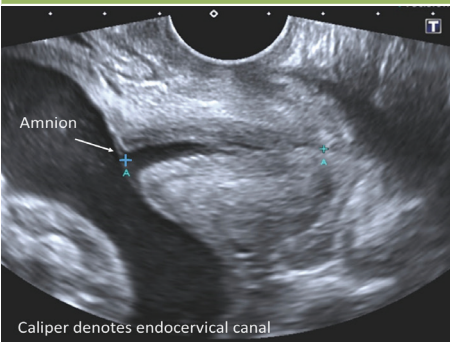
Image 20a: Mucous plug.

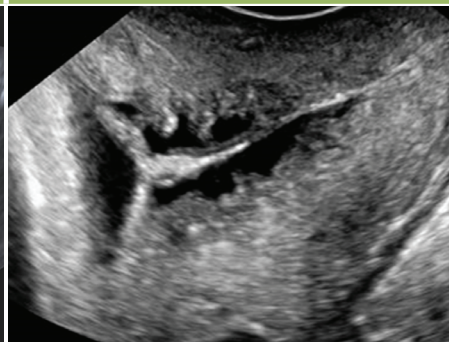
Image 20b: Cervix with hypoechoic glandular tissue

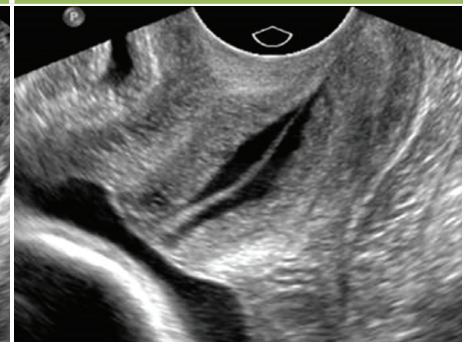
Image 20c: Cervix with hypoechoic glandular tissue.

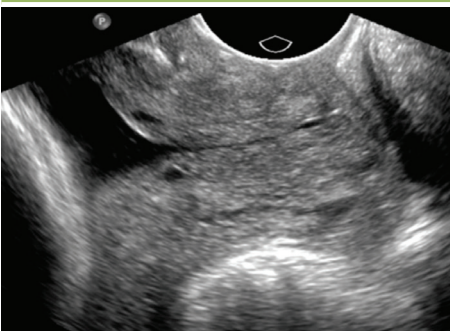
Image 21a: Long, closed cervix.

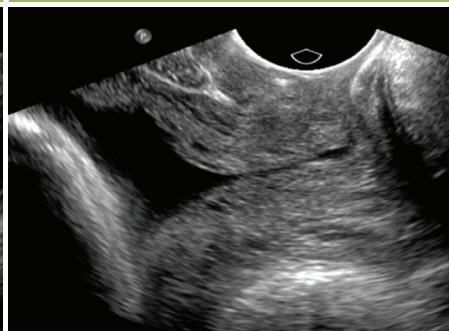
Image 21b: Funnelling and slight opening of internal os.

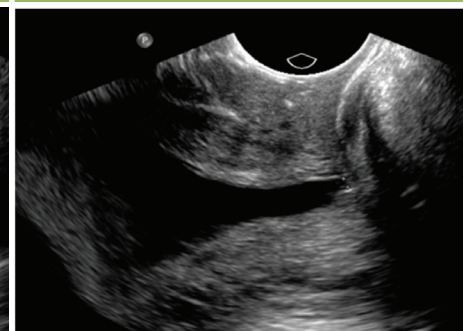
Image 21c: Open cervix, no closed measurable length.

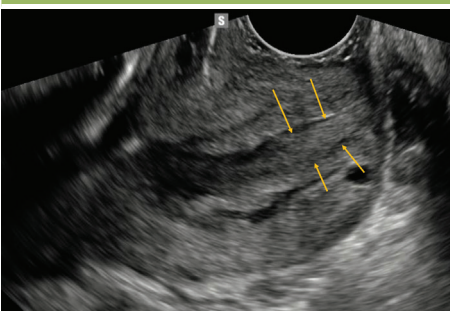
Image 22a: Longitudinal image of cervix, arrows denote polyp

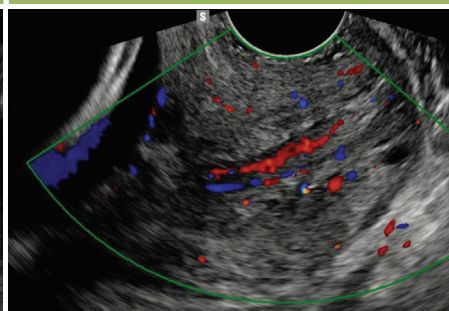
Image 22b: Longitudinal image of cervix, colour Doppler in polyp.

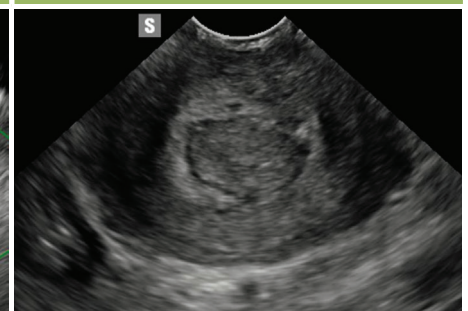
Image 22c: Transverse image of cervix demonstrating polyp.

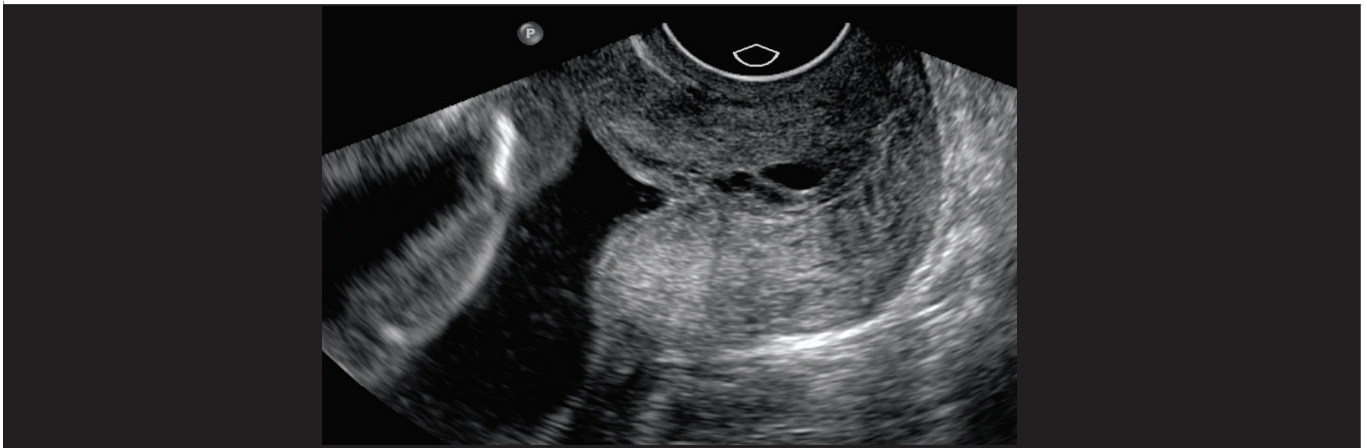
Image 23: Long closed cervix with Nabothian cysts.

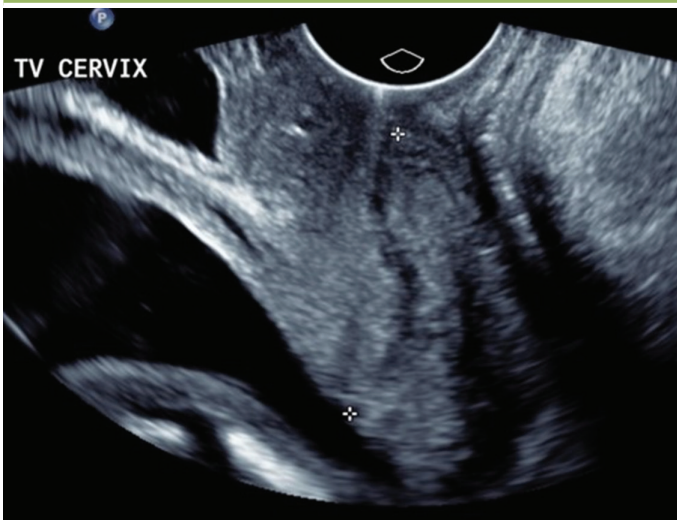
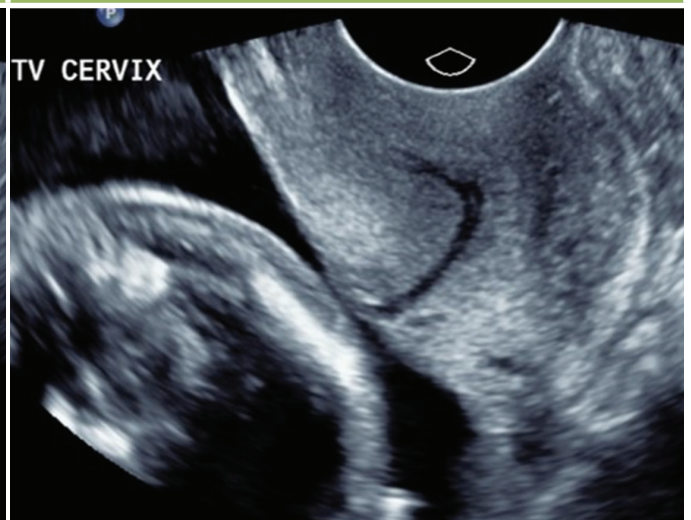
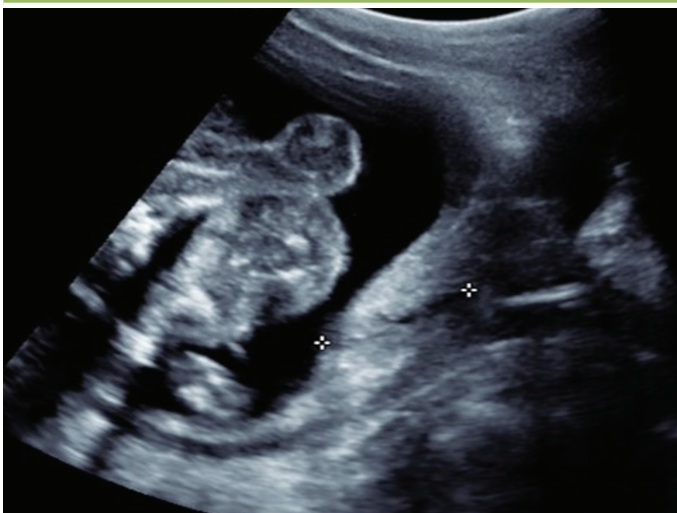
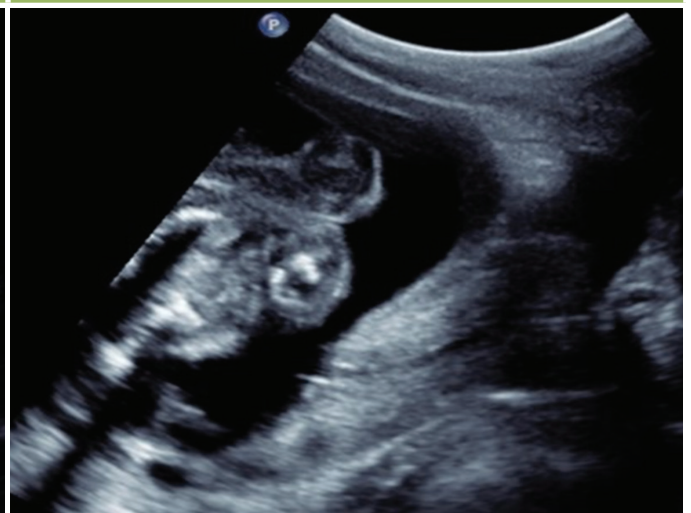
Image 24: TVS examples of undeveloped/immature lower uterine segment in early pregnancy with cervix orientated parallel to vagina. Transabdominal (TAS) images are provided for comparison.

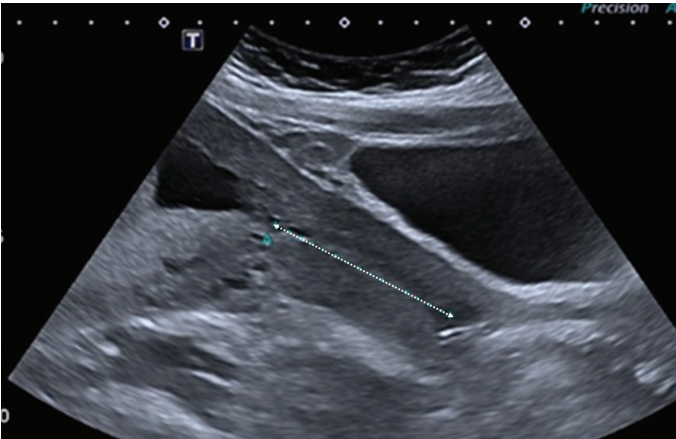
Image 25: Acceptable TAS image of cervix.
(Cervical length=54mm).

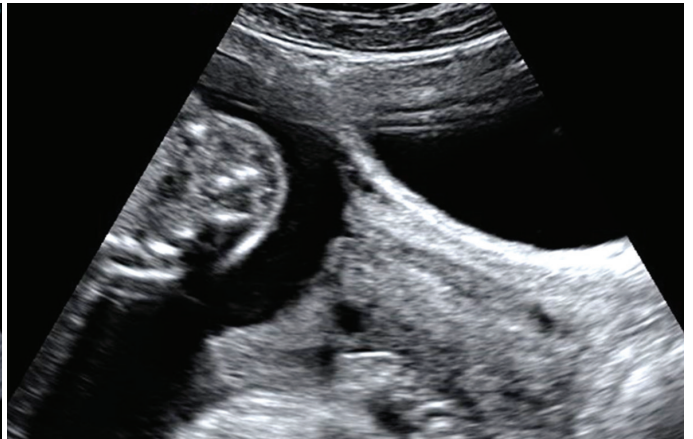
Image 26: Slight overfilling of bladder.
Note: anterior wall of cervix thinner than posterior wall due to bladder filling.

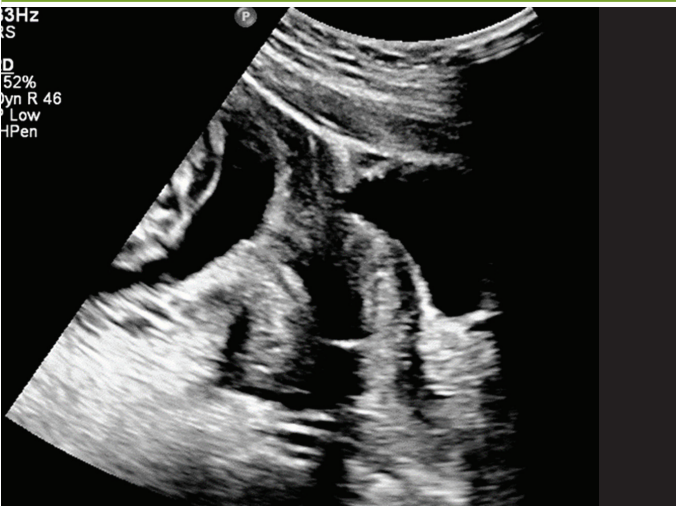
Image 27: Un-acceptable image of cervix.
TVS is recommended.

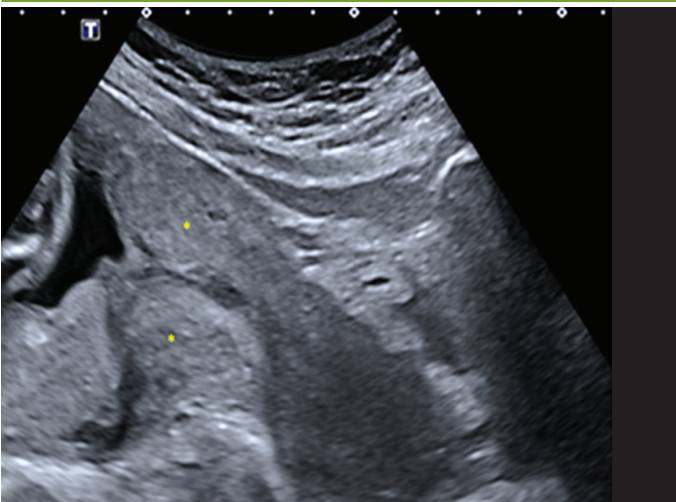
Image 29: Cervix with lower uterine contraction (*)
resulting in inadequate visualisation. Sonographer should
either wait until contraction has subsided or perform TVS
(subject to local protocols and referrer preferences).

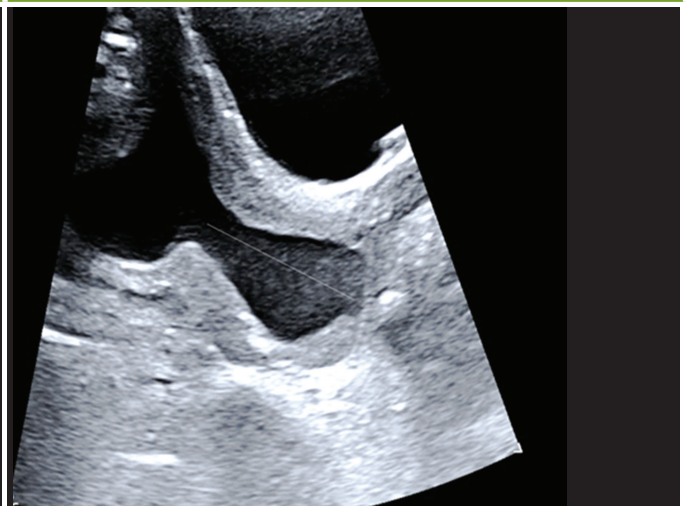
Image 28: TAS image demonstrating open cervix
marked by line. There is funnelling which extends the
length of the cervix. There is no segment of closed
cervix which can be measured. TVS is recommended.

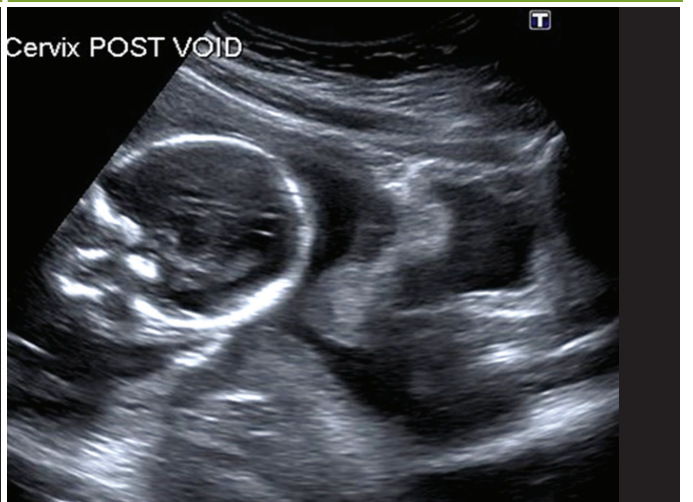
Image 30: TAS open cervix. TVS is recommended
(subject to local protocols and referrer preferences).

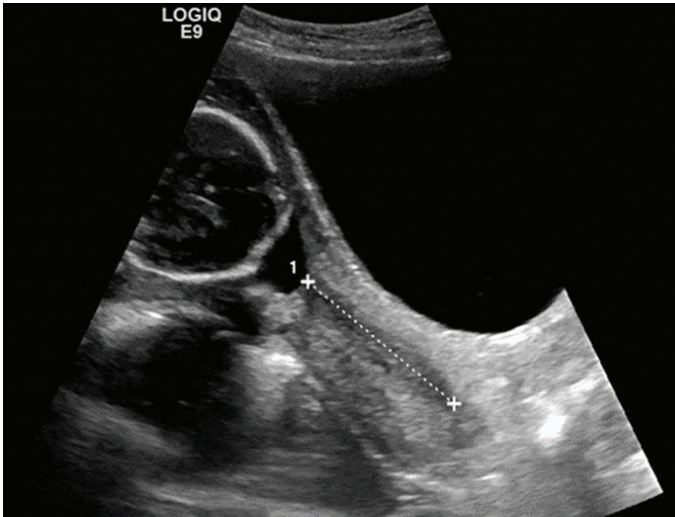
Image 31: Excessive bladder filling, falsely elongating cervix (52 mm).

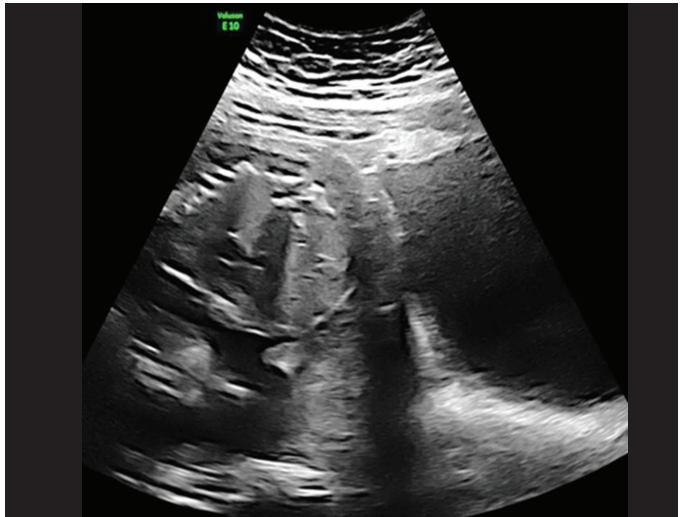
Image 32: Excessive bladder filling resulting in suboptimal image (landmarks not identifiable).

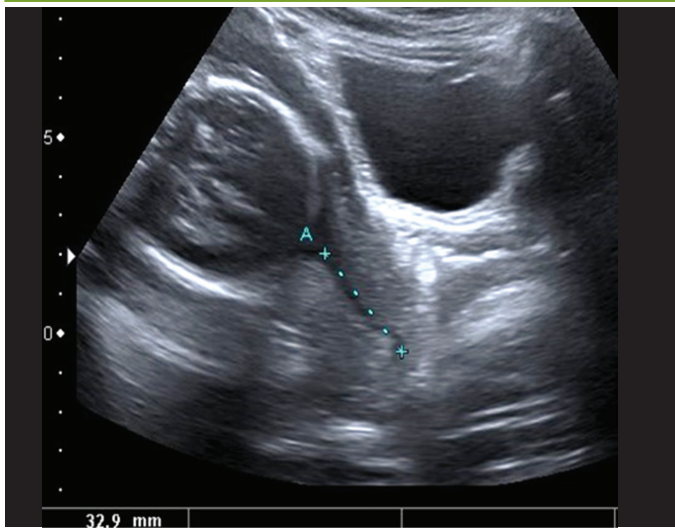
Image 33: Post-void bladder facilitating visualisation of cervix.

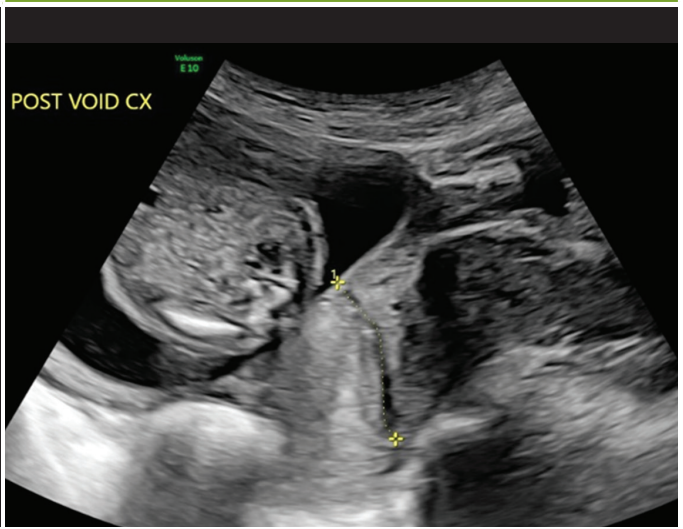
Image 34: Post-void bladder, facilitating visualisation of cervix and resulting in vertical orientation of cervix.

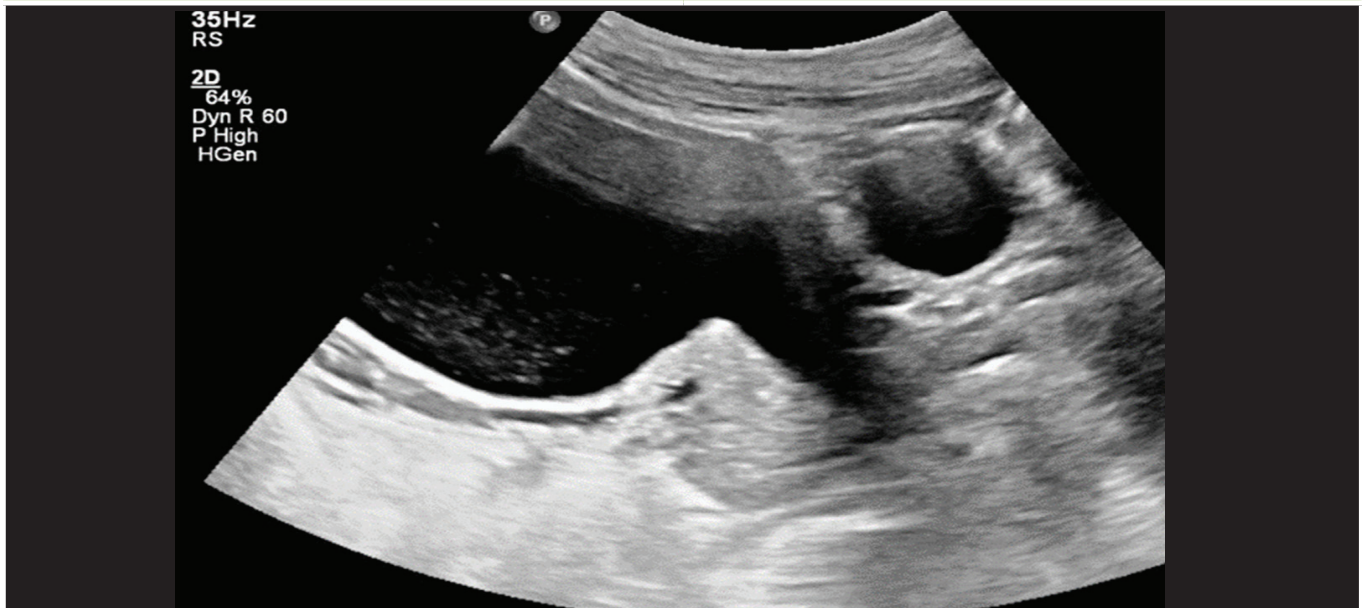
Image 35: Post-void bladder resulting in inadequate imaging. Cervix appears open (i.e., no closed measurable cervix) and TVS is recommended.

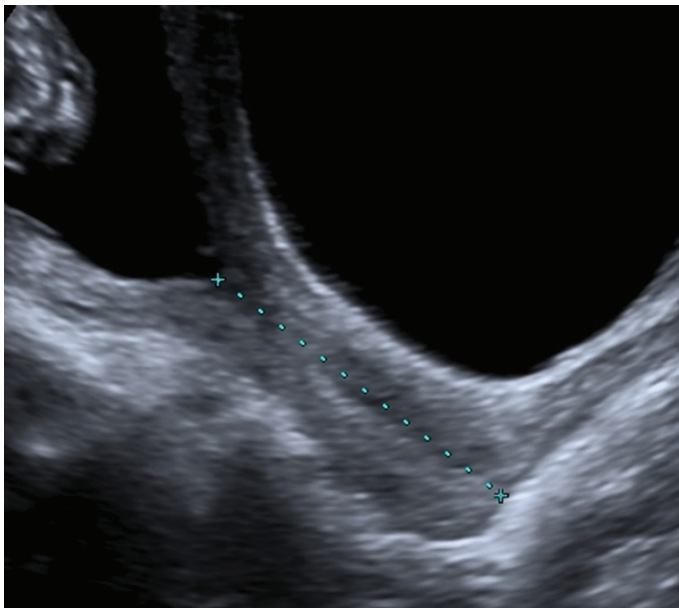
Image 36a: Unacceptable TAS image. Cervical length measurement is falsely long (58 mm) as it includes the lower uterine segment due to excessive bladder filling.

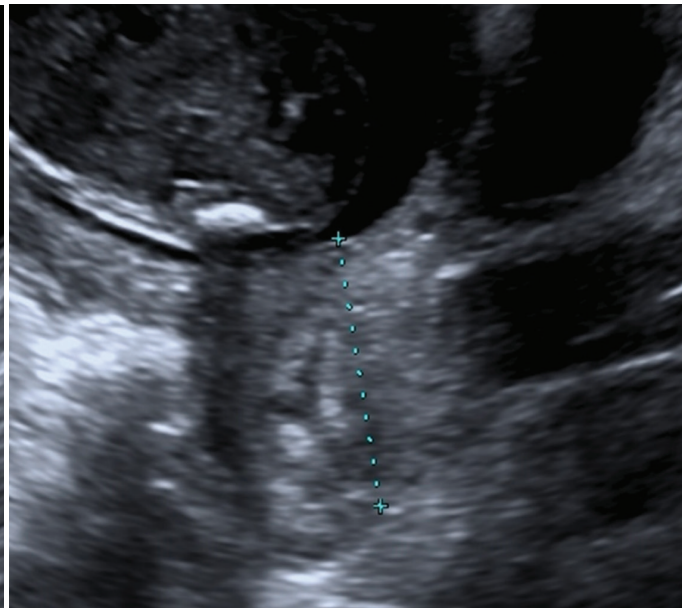
Image 36b: TAS image with empty bladder. Cervical length measurement (34 mm) is slightly overestimated as vaginal wall is included. TVS is recommended.

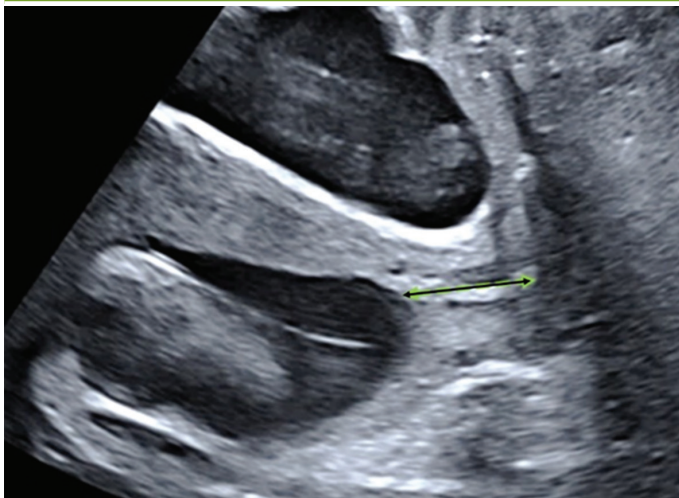
Image 37: Correctly measured cervical canal on TPS image.

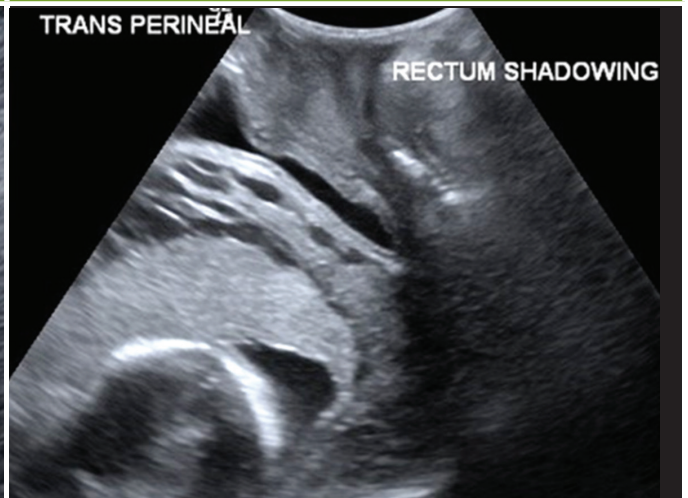
Image 38: Cervical canal, suboptimal image due to rectal shadowing.

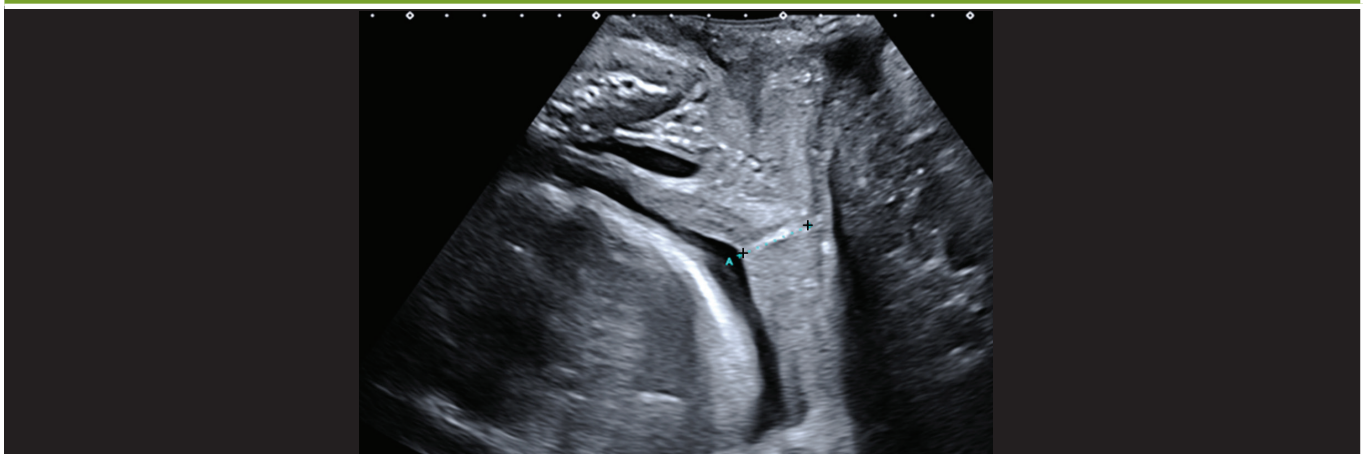
Image 39: Example of a short cervix on TPS image (20.4mm).
